STATUS OF THE MUNICIPAL BEACHES 2025 ANNUAL REPORT CAPE MAY POINT, NEW JERSEY

PREPARED BY: K. McKenna, E. D'Ambrosio, and H. Pimpinelli
COASTAL RESEARCH CENTER, STOCKTON UNIVERSITY
30 WILSON AVENUE
PORT REPUBLIC, NJ 08241

June 16, 2025

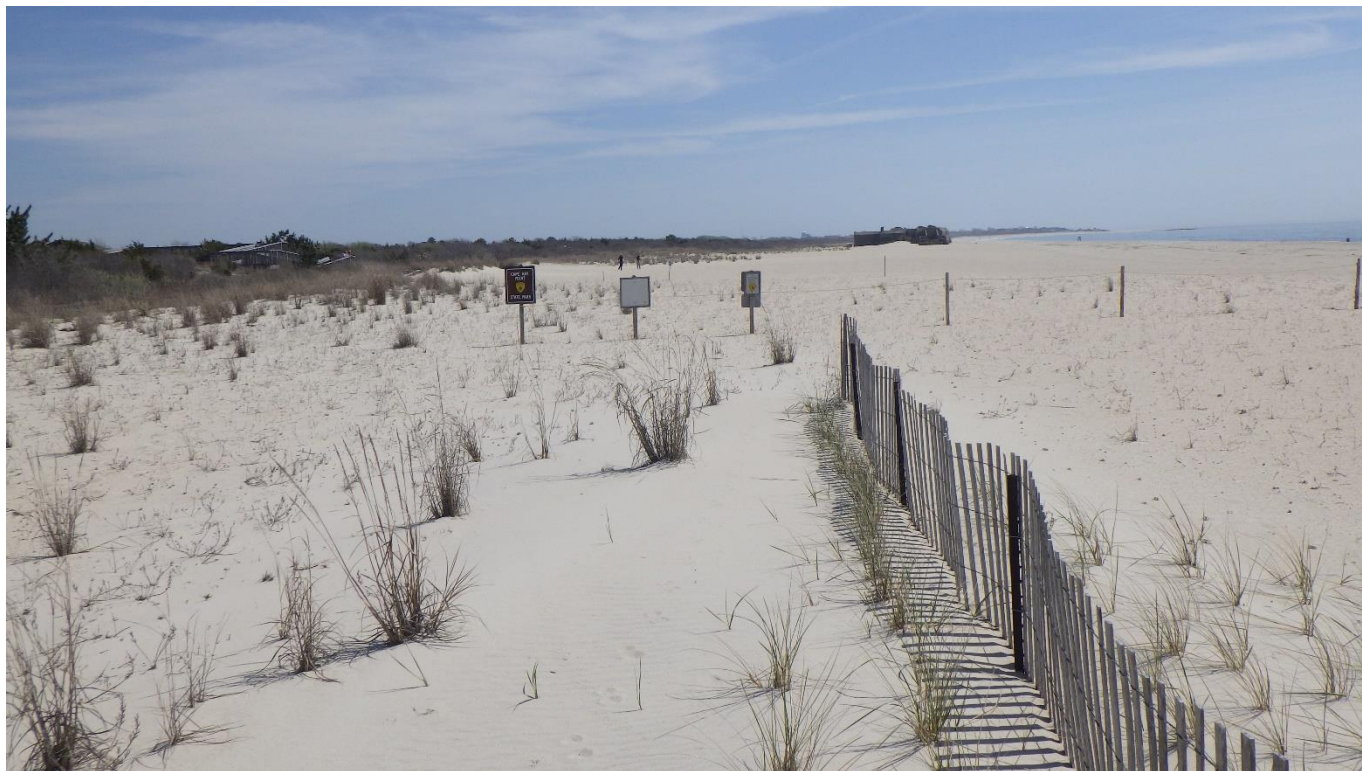
Figure 2. View to the east at the seaward toe of the dunes at Lighthouse Avenue (April 22, 2025). This photo shows the transition into the state natural area. The wide (300+ feet) beach is typical of this location. The WW II battery remains on the dry beach.

The Lighthouse Avenue beach is approximately 375 feet wide from the dune toe to the water's edge. There was landward shoreline movement (-2.3 feet) and volume loss across the profile (-12.8 yds³/ft). Windblown sand, trapped by vegetation created volume gains along the fence line. In the nearshore, the slope remained consistent with the previous three years.

1. The beach cells at CMP-0 (Lighthouse Avenue) and CMP-1 (Lehigh Avenue) do not have reef structures. Between April 2024 and April 2025, the beaches at Lighthouse and Lehigh Avenues experienced net sand volume losses (greater than 5,000 cubic yards in each cell). Most of the sand losses occurred at the seaward berm edge and beachface. Both beach cells have steep nearshore slopes into deep water and strong tidal currents into and out of Delaware Bay.

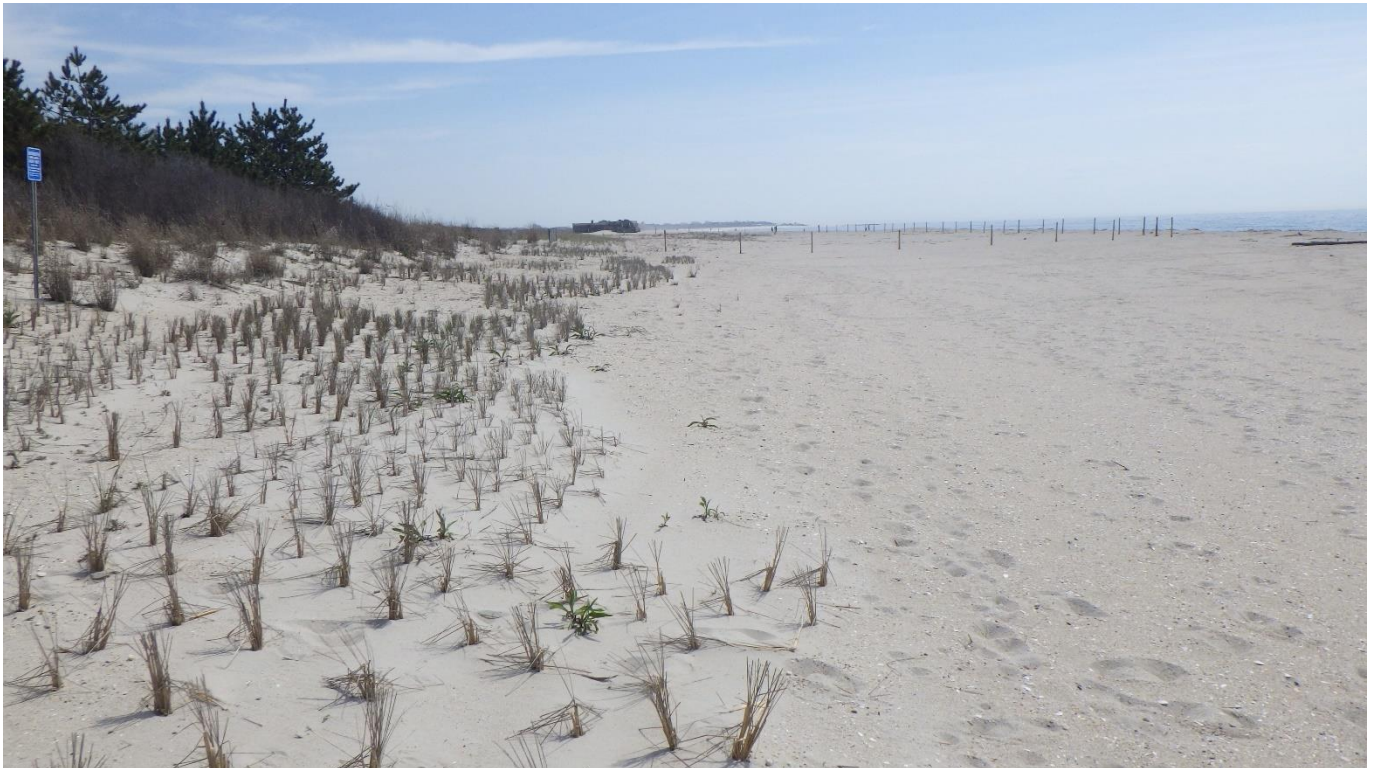
Figure 4. View to the northeast from the dune toe at CMP-1 (April 22, 2025). Vegetation planted between March 2024 and April 2025 trapped windblown sand near the dune toe and appears to allow seaward expansion of the dune. The dune to the left side is located on top of a stone revetment, and the beach remains well wider than the pre-beach nourishment width creating an excellent storm protection barrier as well as a recreational resource.

This cell also received sand during the USACE authorized second maintenance project conducted between November 2012 and January 2013. That project counted both the Lighthouse and Lehigh sites as one placement volume at 78,174 cubic yards. No sand placement has occurred here since that time. Between March 2024 and April 2025 CMP-1 lost sand above and below the 0.0 ft NAVD88 elevation as the seaward berm crest lowered and the nearshore moved landward (-12.2 yds³/ft.). However, the shoreline moved seaward (4.5 feet).

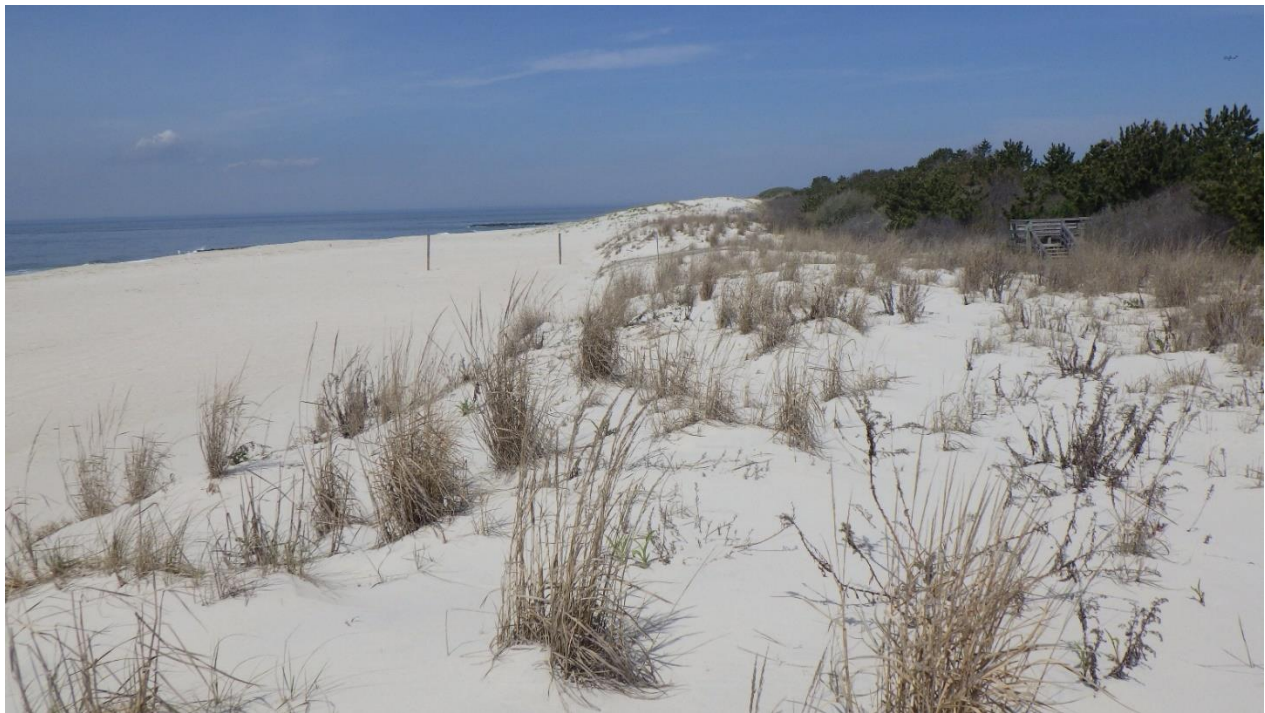
Figure 6. The photo shows a view to the northwest from the foredune at Whilden Avenue (taken April 22, 2025). The dune gained in elevation from March 2024, but the dune toe did not expand seaward, thus leaving approximately 150 ft of dry beach for recreational use.

The 2021 cycle of USACE sand placement did not directly place sand into this groin cell. In 2024-2025 there was sand volume loss above and below the datum ($-13.1 \text{ yds}^3/\text{ft.}$) and landward shoreline movement (-10.6 ft). The “Beachsaver” units are buried in the center of the beach cell and are exposed with any lowering of the seafloor elevation. In 2025, the units are exposed at about -5.0 ft NAVD88 and may become a hazard to water bathers. Caution is urged to water bathers in the area surrounding the unit and in-water bathing beyond 3-foot depths is not recommended. In addition, these individual 10-foot-long reef concrete units did not settle into the seabed in a uniform manner over time. Early traverses along the crest between the rock groins found that units tilted from end to end and were of differing crest elevations between adjoining segments so exposure could easily vary along the line of the reef structure, buried in places, but exposed at the surface in others.

2. The cell 2 at Whilden Avenue (CMP-2) shoreline position (zero datum) is approximately 75 feet landward from the “Beachsaver” unit. This unit was exposed at 513 feet from the profile baseline and the elevation at the top of the unit measured at -6.1 ft NAVD88. There is a continued risk of injury to unwary visitors if this structure remains exposed over the summer of 2025. The CRC recommends not allowing swimming in this cell except for wading into 3 feet of water and installing a line of floats indicating the maximum distance into the water which should be about 20 feet from the “Beachsaver” unit.

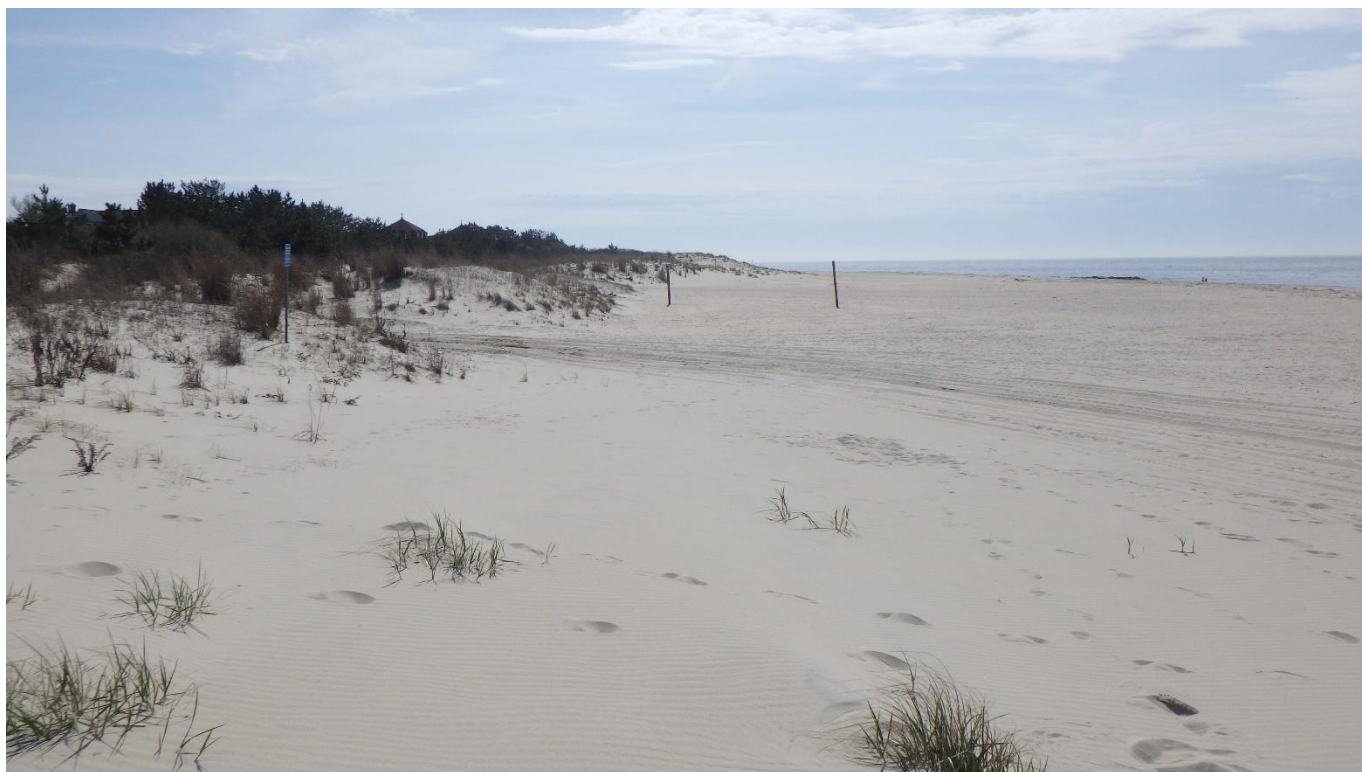
Windblown sand continued to accumulate at the dune toe and that has allowed seaward growth of the foredune since 2021. In 2024-2025, this is the only groin cell within the Borough that gained volume, and the shoreline moved seaward. The sand volume change was a gain of 5.24 yds³/ft and the shoreline moved seaward (8.45 ft).

Figure 8. View to the southeast of the seaward foredune toe and backshore at profile CMP-3. In April 2025, the foredune peak was 13.1 ft NAVD88, two feet higher than in March 2024 (photo taken April 22, 2025).

offshore below the 0.0 ft NAVD88 datum. The “Beachsaver” units (approximately 500 feet seaward from the baseline) were found to be buried by sand in the April 2025 survey. Markers or floats should be used if swimming is allowed.

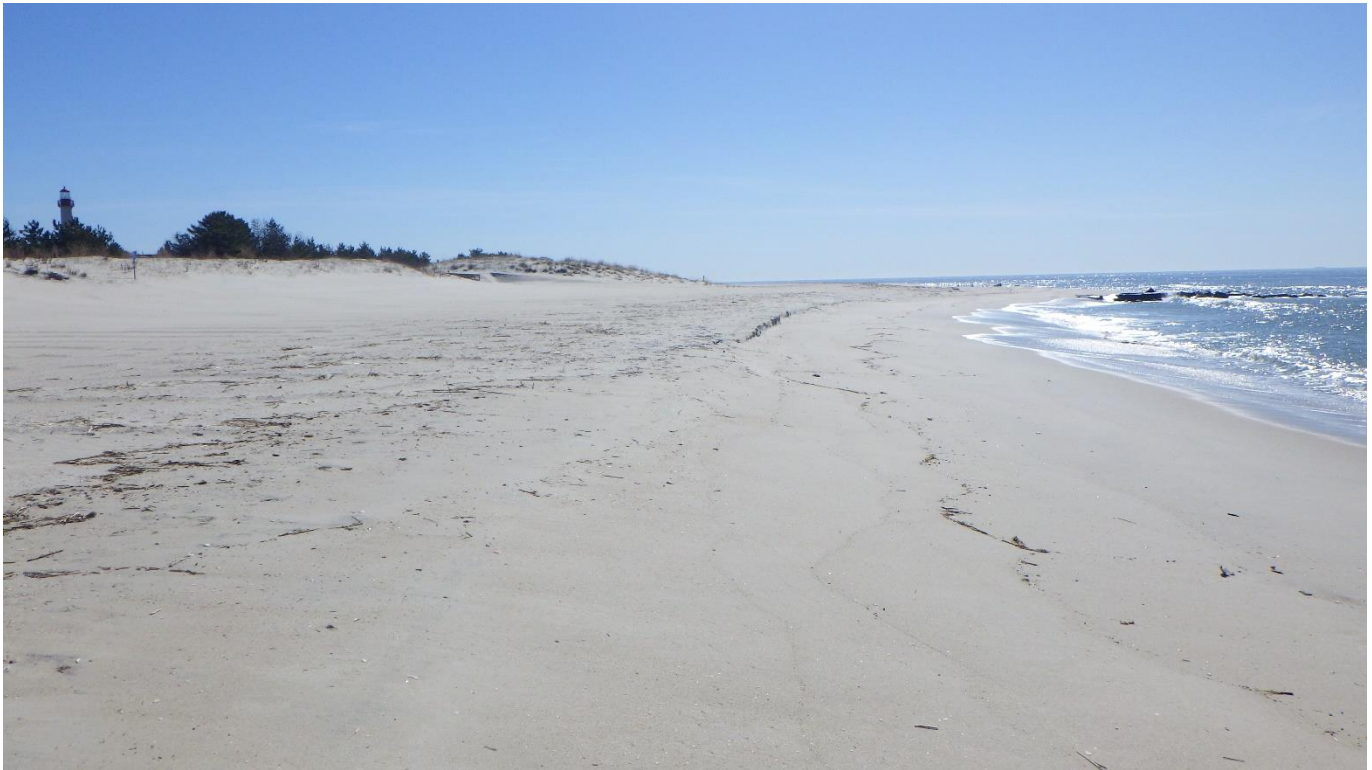
Figure 10. The March 19, 2025 photo at profile CMP-4 shows the conditions of the berm crest and beachface with evidence of a berm scarp closer to the Coral Avenue groin. The backshore elevation adjacent to the dune toe was half a foot lower than measured in the March 2024 survey.

The CMP-4 beach profile survey was completed two days after the passage of a storm that brought 4-6 ft waves from the southeast and onshore winds. A berm scarp was present southeast of the profile line, but not within the rest of the groin cell to the northwest.

4. Beach cell 4 (CMP-4, Lake Ave.) has no structures and typically has a relatively shallow nearshore slope than the groin cells to the southeast. The USACE added 50,000 cy of trucked sand in 2021, but none since then. This beach cell remains a good option for a swimming beach in Cape May Point this season. The shallow slope of the nearshore between the groins makes wading and swimming much safer for beach patrons.

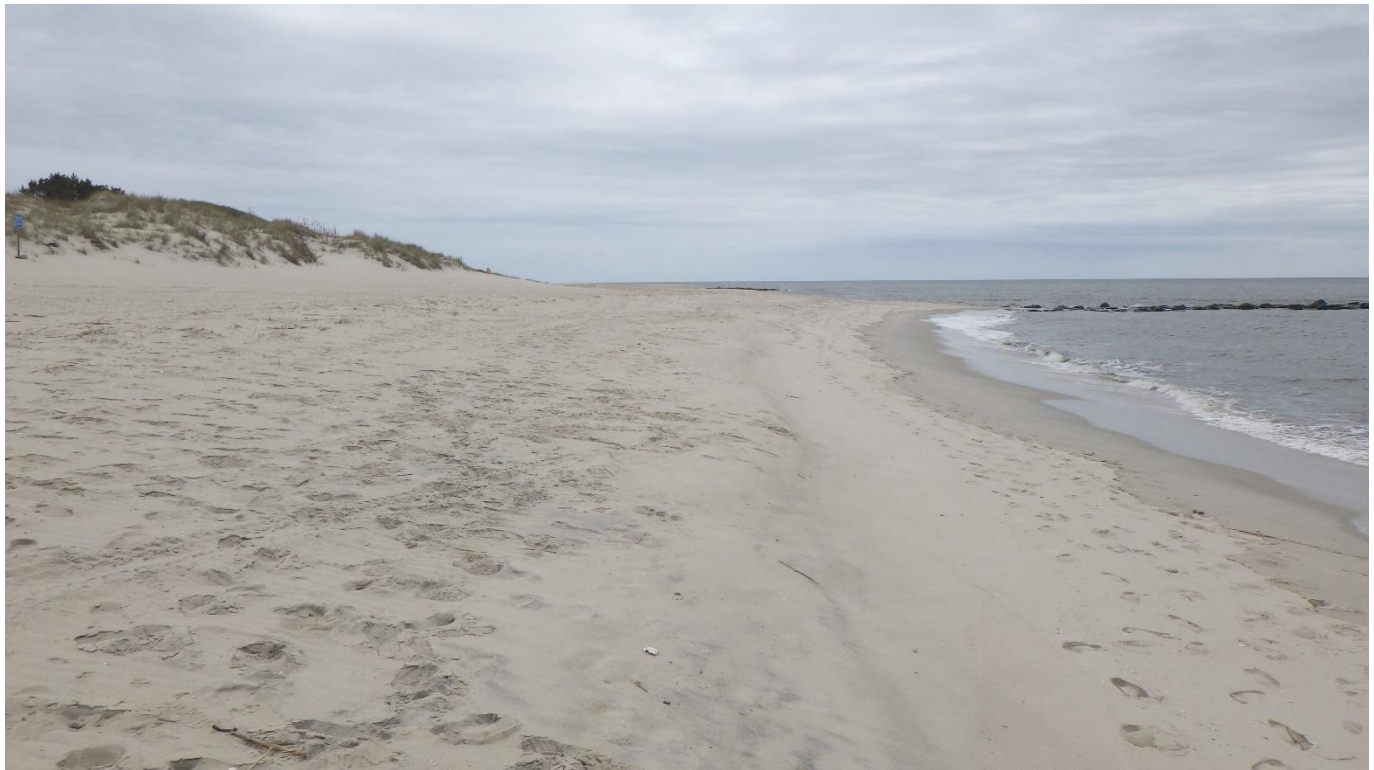
No sand was placed northwest of Lake Drive during the 2012-2013 USACE renourishment project nor during the 2016 or 2021 efforts. In past studies of the Borough’s beaches, natural processes have moved sand from southeast to northwest along the shoreline over time. At CMP-5 the groin cell lost volume below 0.0 ft NAVD88 between the April 2024 and April 2025 surveys. The foredune gained elevation and expanded seaward contributing to the above datum volume gains. The profile lost volume below the datum as the nearshore slope moved landward (across profile -1.07 yds³/ft.), and the shoreline moved landward (-5.8 ft).

Figure 12. The April 21, 2025 view to the southeast from profile CMP-5 shows the dune, berm scarp, beachface and the Surf Avenue groin. The dry beach landward of the “Beachsaver” unit was about 100 ft in width.

The gain in foredune elevation and width continued as windblown sand was trapped by vegetation. The dune growth has been continuous since 2018 regardless of the shoreline position or beach volume change.

5. Beach cell 5 (Cape Avenue, CMP-5) and beach cell 6 (Pearl Avenue, CMP-6) contain submerged breakwater units that were installed in 2002. At CMP-5, the units were detected at 700 feet from the baseline and there was scouring seaward of the structure. Swimming areas are nearly 200 feet between the shoreline and the “Beachsaver” unit which had a top elevation at -5.9 ft NAVD88. The “Double T” structure in beach cell 6 has been long buried by sand. Swimming near the groins that mark the cell boundaries should always be avoided since the units are slightly closer to the beach adjacent to the rocks. Both beach cells had minimal volume losses (cell 5) or gains (cell 6) over 2024-2025.

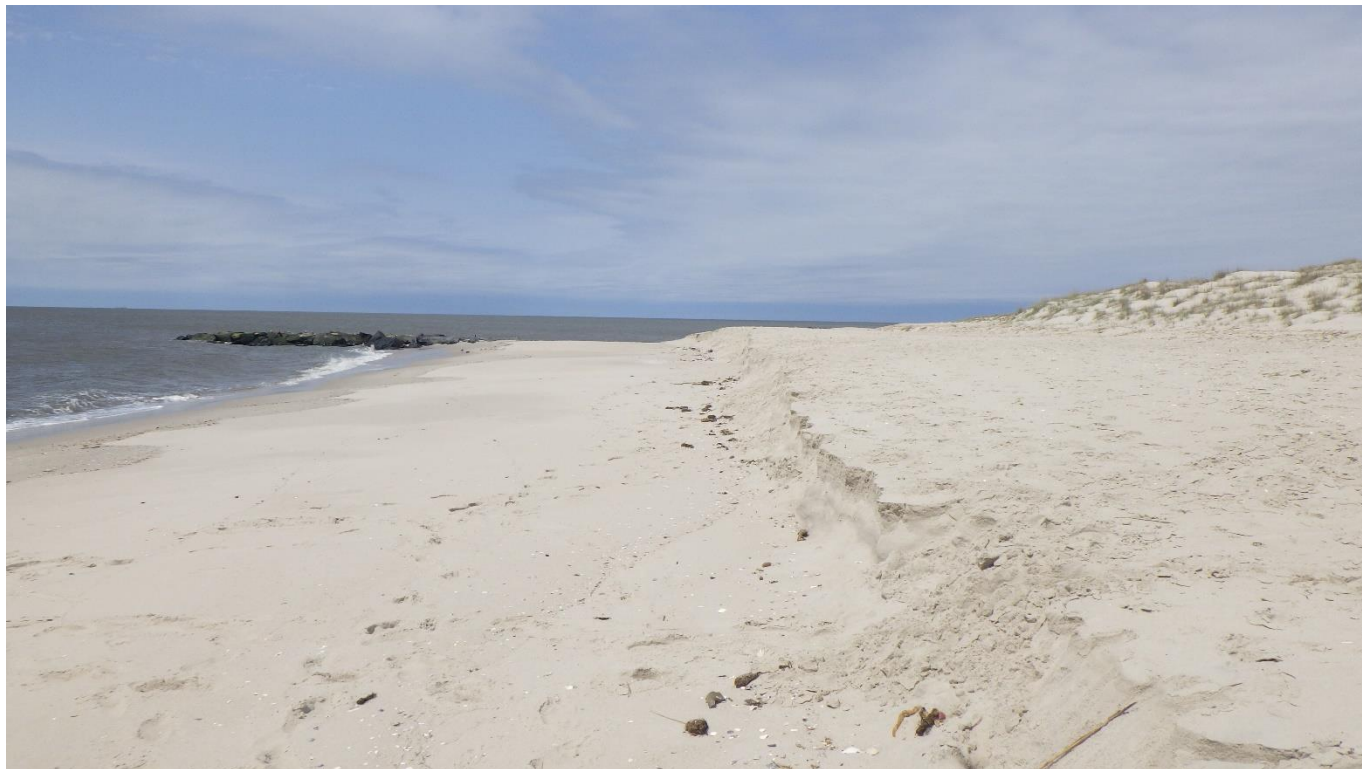
Figure 14. The photo from profile CMP-6 shows a one-foot berm scarp and a 100 ft dry beach (taken April 21, 2025, view to the northwest). The foredunes here have grown upward and seaward since 2021 as a result from accumulated windblown sand.

No sand was placed this far northwest in any of the USACE beachfill projects, so the beach building that occurred here over the past four years was the result of natural processes that moved sand from the updrift beaches (southeast of this location). The CMP-6 profile gained a modest amount of volume between 2024 and 2025 (1.22 yds³/ft.) with most sand gains occurring below the datum and offshore (from 850 ft to 990 ft. from the baseline). This groin cell and the groin cell bounded by Whilden Avenue and Coral Avenue (CMP-3) were the only two Borough beaches that gained volume over the past year (Table 1).

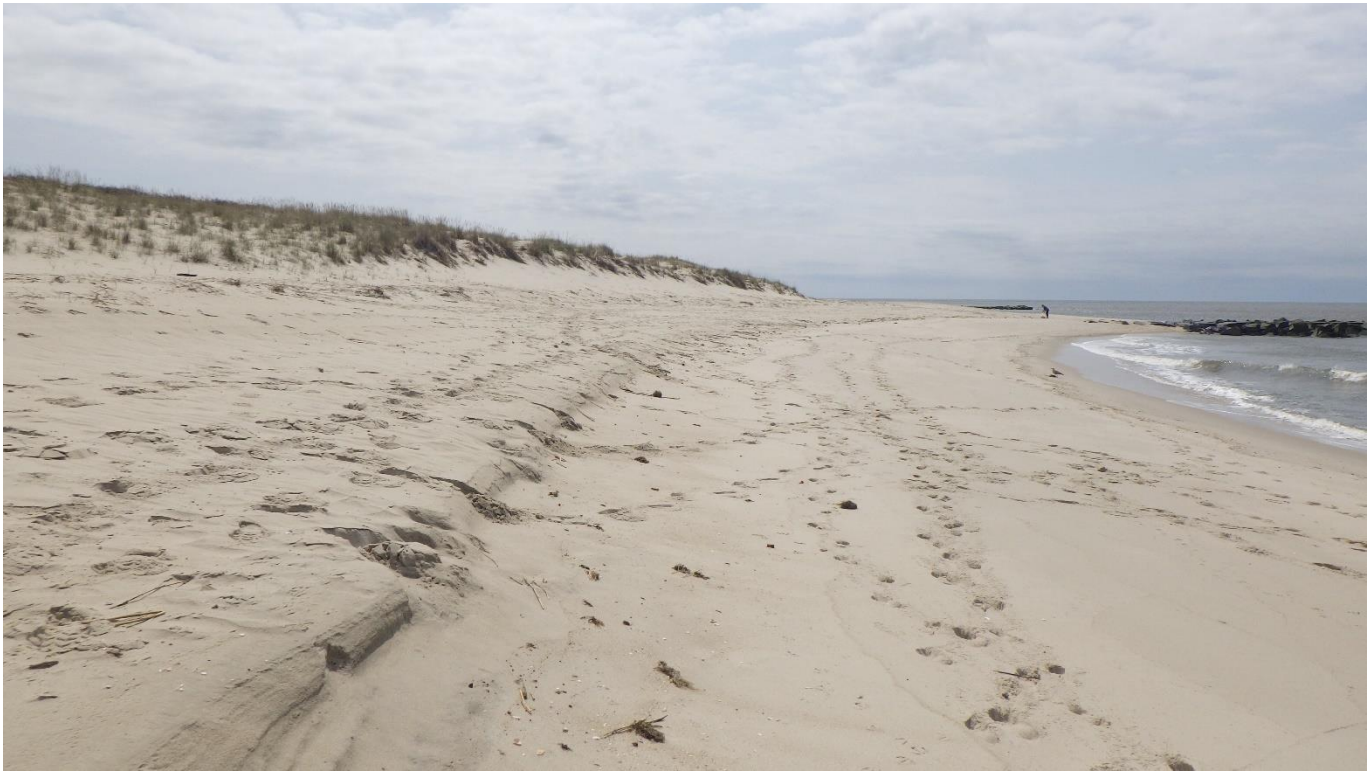
Figure 16. The April 21, 2025 photo (view to southeast) at profile CMP-7 shows a distinct berm scarp and planed beachface that is evidence of high wave conditions from the south that occurred a few days before the survey. The foredune continued to grow seaward over 2024-2025; evidence that there is ample natural sand transport to this groin cell.

In 2025, the dune crest elevation was 31.8 ft NAVD88. The high and wide dunes provide excellent storm protection to the Borough's infrastructure and homes. The dunes and backshore have gained sand since 2021 and the entire foredune slope has become a dune field since 2018 with elevations greater than 12 ft NAVD88. The storm prior to the 2025 survey eroded the seaward portion of the berm and moved the shoreline landward (-30.2 ft).

6. Beach cell 7 at Stites Avenue (CMP-7) benefited from growth of the foredunes and berm, enhancing the recreational value of the beach again over 2024-2025. However, the south-southeast driven swell a few days before the CRC’s survey created a berm scarp and planed beachface and there was a sand volume loss from the April 2024 conditions. Even with the overall volume losses, the nearshore remained shallow and there were sand gains 700 feet from the profile baseline. This cell may offer a relatively safe option for swimming.

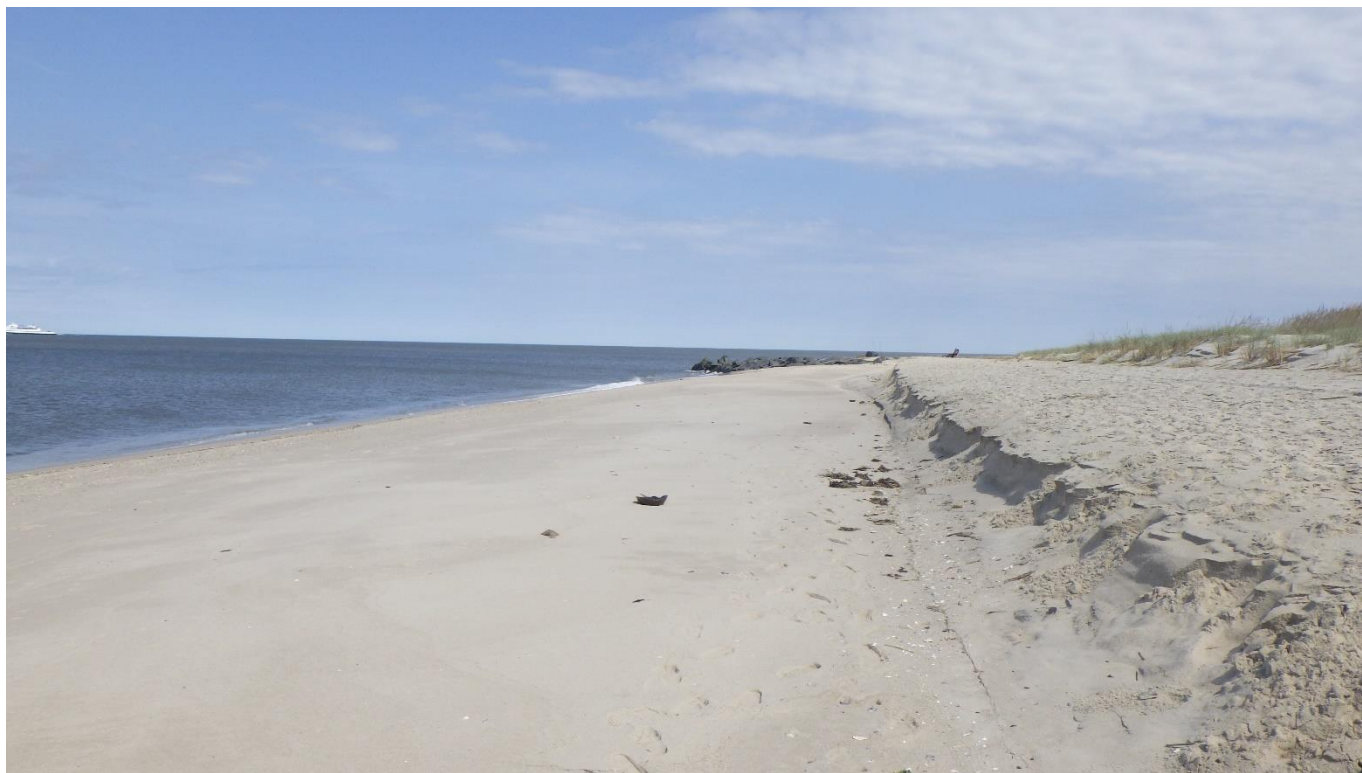
Figure 18. The April 21, 2025 photo (view to the northwest from the CMP-8 profile) shows a distinct berm scarp that was most-likely created from a south-derived swell event that occurred April 18-19. The dune field continued to grow over 2024-2025.

In previous years, the CMP-8 profile has reliably gained in sand volume. The dune field and berm have grown in width and height since 2017. This is evident in the extensive foredune field landward of the dry beach. However, in April 2025, the shoreline moved landward (-41.6 ft). This is unusual for this location and the shoreline here moved the most landward of the measured transects along the Cape May Point coastline. This profile also lost the most sand of the Borough’s beaches (-13.26 yds³/ft.).

7. Beach cell 8 at Alexander Avenue had the largest sand losses of all the Borough’s beaches, with most losses occurring at the seaward berm edge (evident by a scarp in Figure 18). In past surveys, this beach cell has consistently accumulated sand across the foredunes, dry beach, and nearshore. This beach has traditionally been closed to swimming. Allowing water access would entail the hiring of additional lifeguards.
