THE RICHARD STOCKTON COLLEGE OF NEW JERSEY

**Introduction:**

The annual survey of the nine cross section stations on the municipal beach was completed by the Richard Stockton College of New Jersey Coastal Research Center on April 8 and 10, 2014. These were compared to previous studies that were completed in April 2012 and April 2013. This work completes the annual review of the municipal beaches prior to the 2014 tourist season.

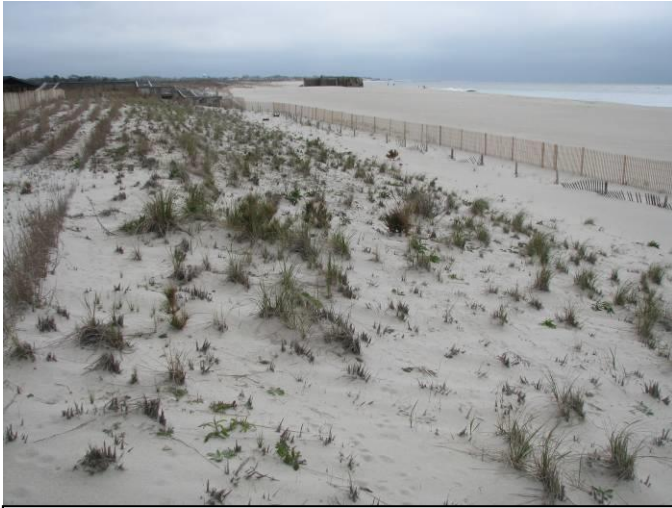
*By April 2013 a new row of fencing was added seaward of the partially buried row present earlier. The berm elevation was higher and further seaward than a year earlier.*

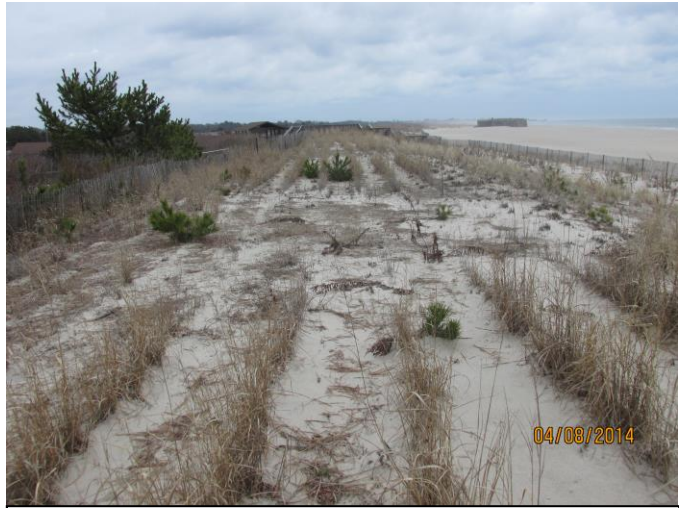
*The photo taken on April 2014 shows the dune and beach remained remarkably stable this year. There were no visible changes to the beach or dune system.*

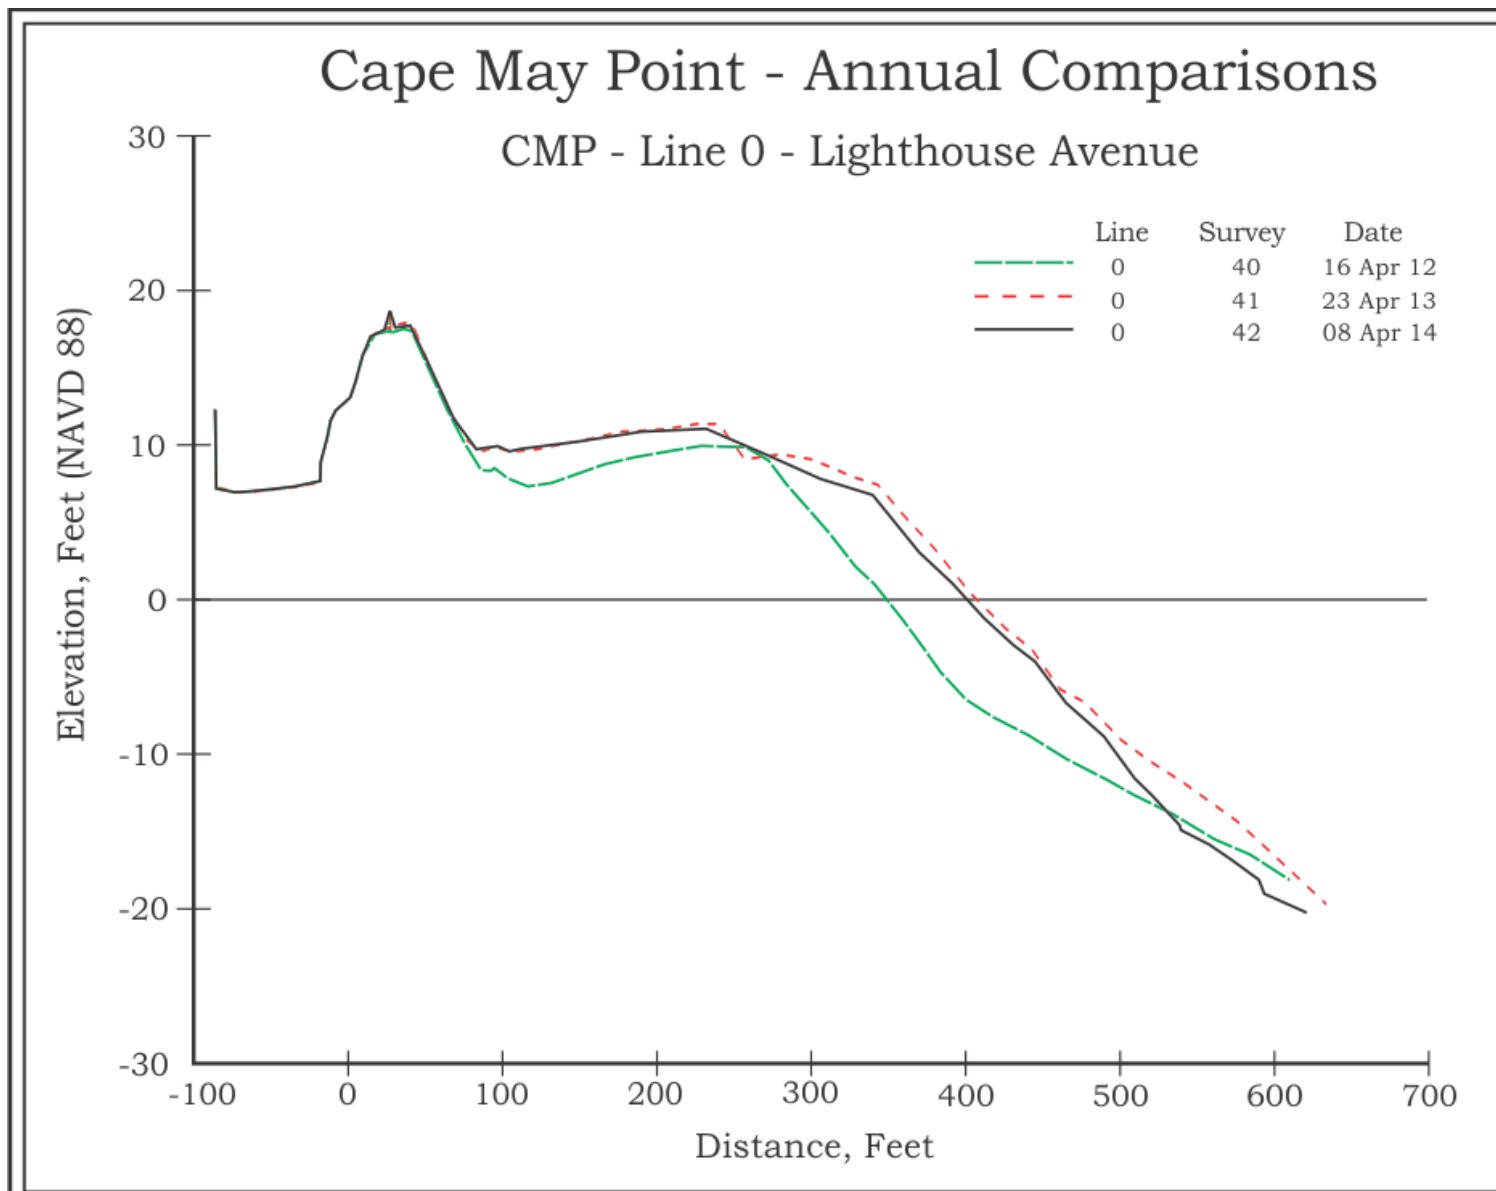
The beach and dune system remained stable through April 2014. Modest beach erosion along the beachface slope removed some sand from the system. The shoreline retreated a modest 6 feet while 17.28 yds<sup>3</sup>/ft. of sand eroded from the site. Most of the eroded sand (-13.35yds<sup>3</sup>/ft.) was from the offshore slope with a modest loss of sand from the berm and beachface. This beach still provides ample storm protection to prevent significant storm damage to the dune system and oceanfront properties while aeolian sand from the beach continues to feed sand to the seaward dune slope and foredune around installed dune fences. The beach configuration on April 8, 2014 closely mimicked the April 2013 profile. The beachface slope remains relatively steep at a rate of approximately 10 to 1 so that within 200 feet the seafloor goes from 0 to -20 feet NAVD 88. Proximity to the nearshore tidal channel also causes stronger longshore currents along this shoreline.

**Figure 1. Following Hurricane Sandy the USACE 2<sup>nd</sup> maintenance nourishment project restored the beach sand adding to the recreational beach berm and beachface. The project increased the beach elevation up to 2.5 feet (10-11ft. NAVD88) and pushed the beach width seaward 60 feet. The beach remained relatively stable with modest erosion along the beachface. By April 8, 2014 the shoreline position retreated 5.8 feet with a modest loss of 17.28 yds<sup>3</sup>/ft. of sand mostly derived from offshore losses.**

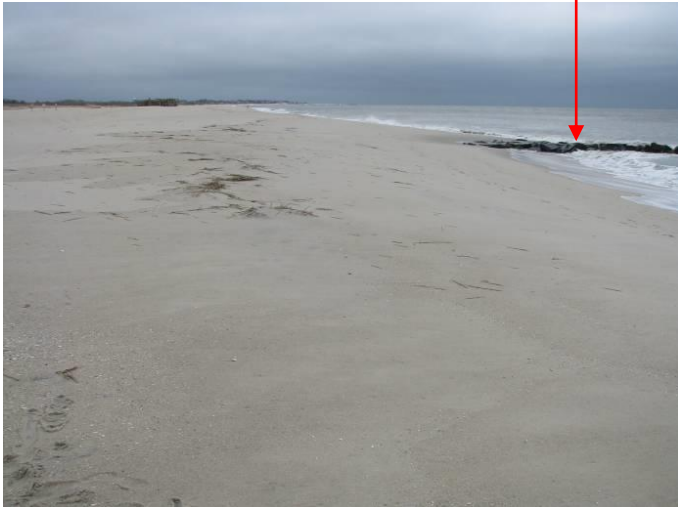
*The photo taken on April 2013 the cell is completely filled with sand added to the berm elevation burying most of the exposed groin rock at the beachface.*

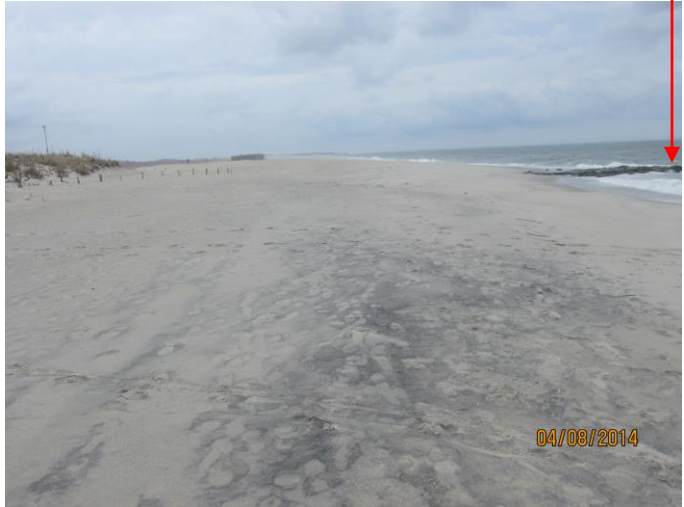
*Taken on April 8, 2014 this photo shows beachface erosion has exposed more of the rocks along the shoreline. Note the positions of the red arrows in each photo.*

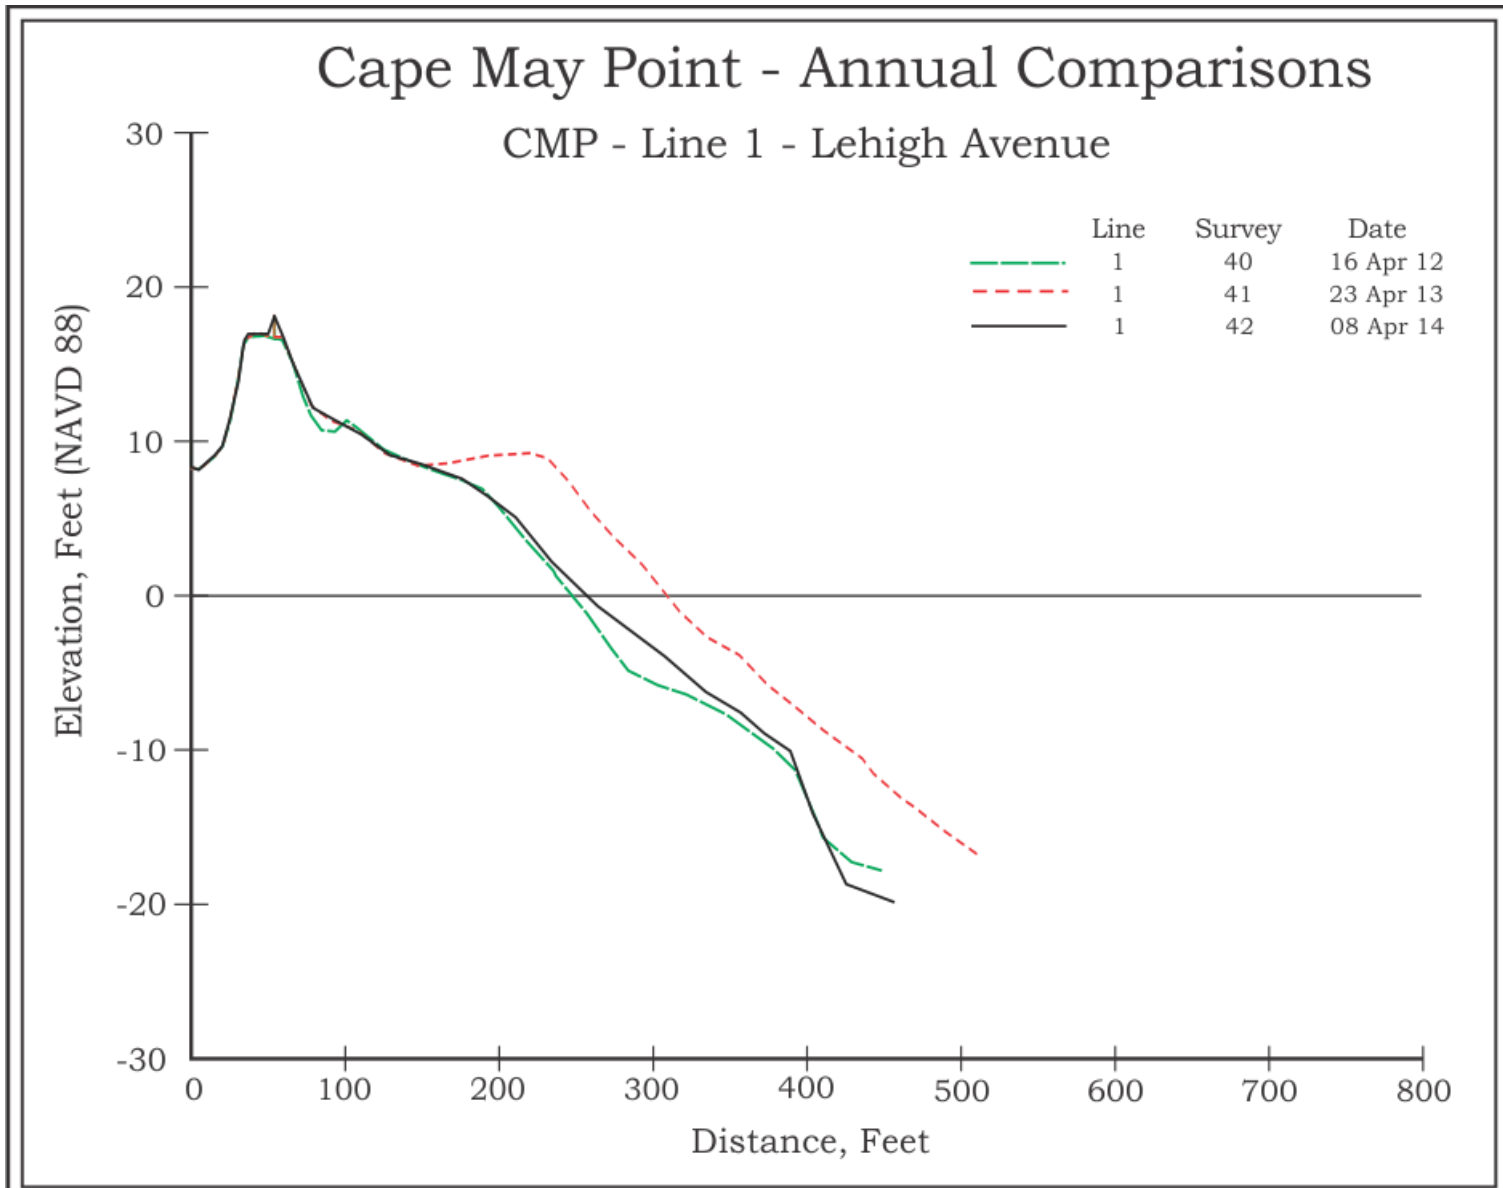
The project beach rapidly eroded through April 2014. Moderate beach erosion along the beachface slope removed some sand from the system. The shoreline retreated 51 feet while 51.78 yds<sup>3</sup>/ft. of sand eroded from the site. Most of the eroded sand (-32.57 yds<sup>3</sup>/ft.) was on the offshore slope with the other third from the berm and beachface. This beach still provides ample storm protection to prevent significant storm damage to the dune system and oceanfront properties while aeolian sand from the beach continues to feed sand to the seaward dune slope and foredune around installed dune fences. The beach configuration on April 8, 2014 closely mimicked the April 2012 profile. The beachface slope remains relatively steep within the initial 125 feet the slope then steepens to an angle of repose slope into the adjacent tidal channel. Proximity to the nearshore tidal channel also causes stronger longshore currents near the end of the groins.

**Figure 2. Again following Hurricane Sandy the USACE 2<sup>nd</sup> maintenance nourishment project restored the beach sand adding to the recreational beach berm and beachface. The project pushed the beach width seaward 60 feet at elevation 10 NAVD88. The beach rapidly eroded and removed nearly all of the sand placed during the project. By April 8, 2014 the shoreline position retreated 51 feet with a loss of 51.78yds<sup>3</sup>/ft. of sand mostly derived from the project area that included the steep offshore slope.**

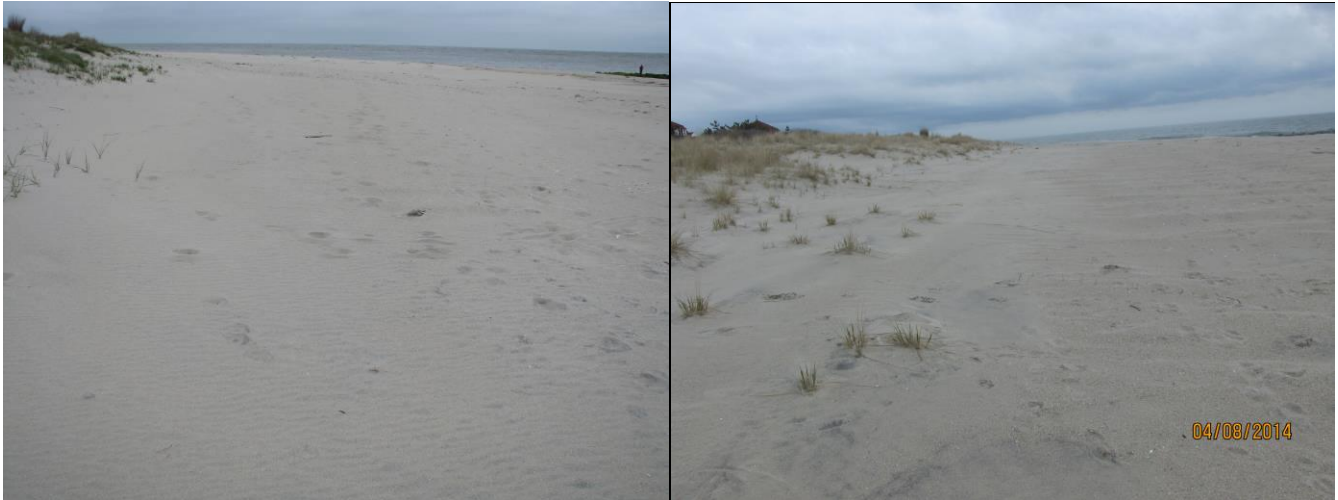
*The photo above was taken from along the seaward dune toe in April 2013. Plants are colonizing the seaward dune slope where aeolian deposition has expanded the feature seaward.*

*The photo taken on April 8, 2014 shows continued aeolian accumulation and colonization of plants seaward onto the open beach. The overall beach width and elevation remained relatively stable over the year.*

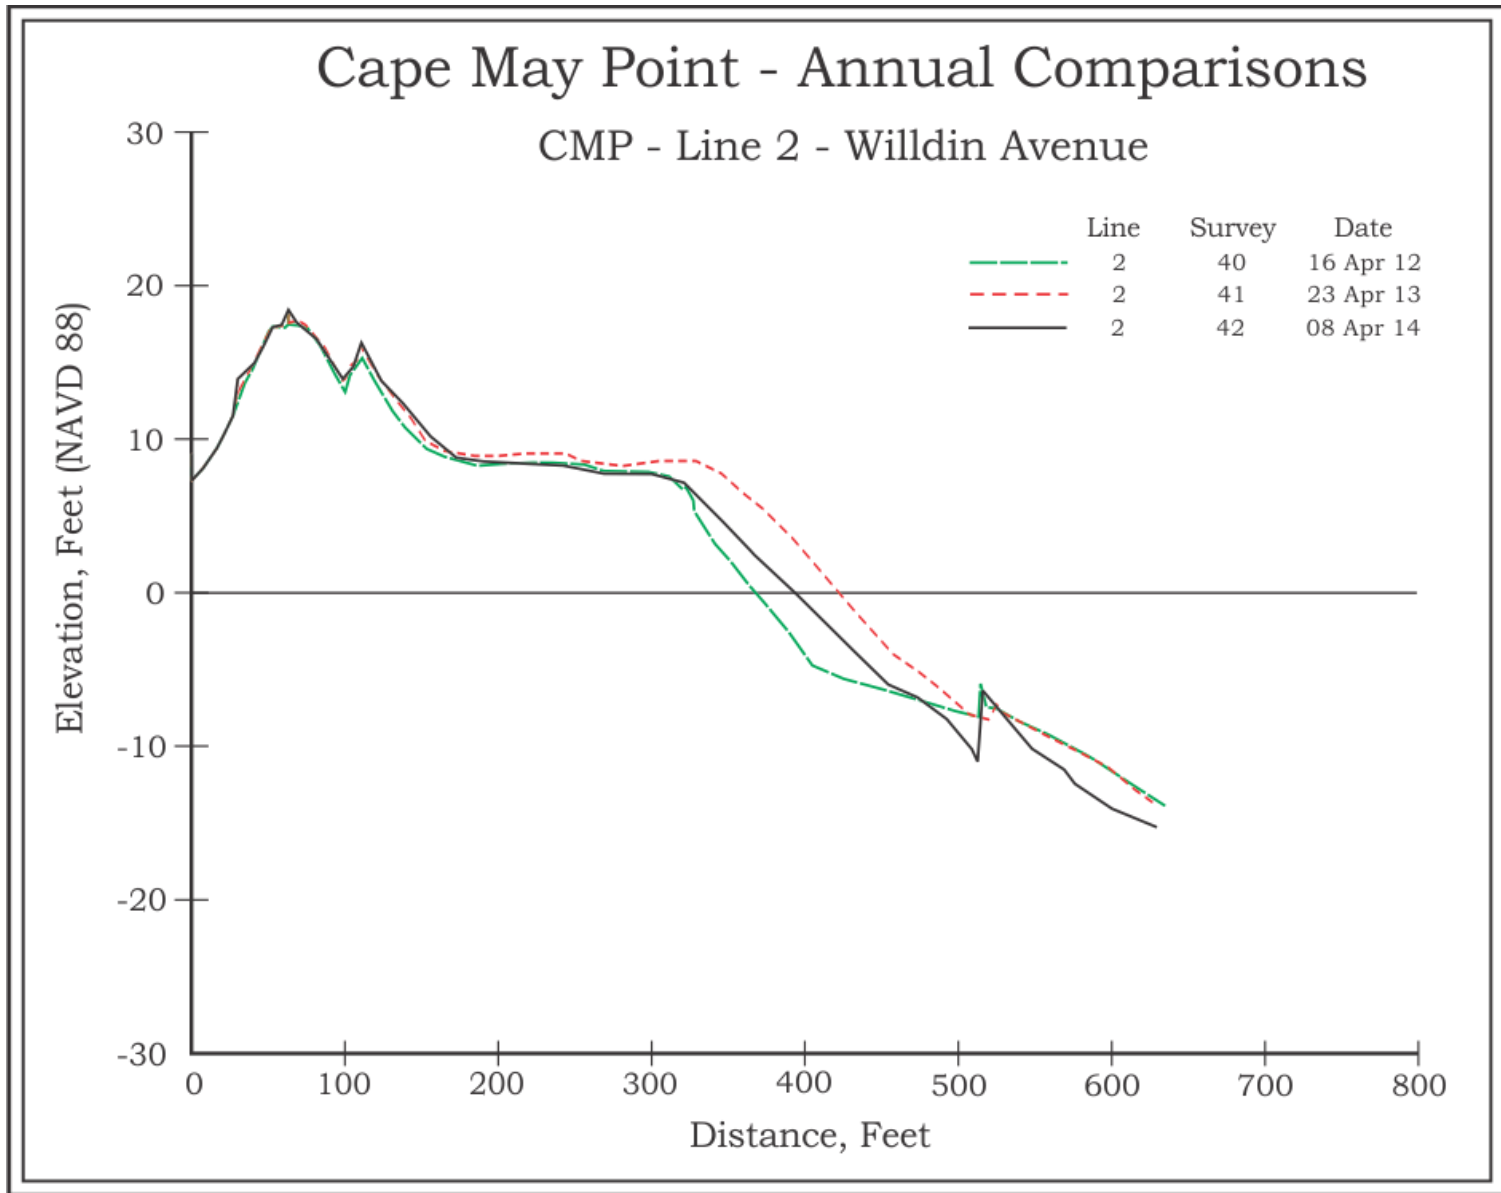
Sand shed from the recent project beaches accumulated rapidly in this cell during 2013. The site gained 32.58 yds<sup>3</sup>/ft. of sand and the shoreline advanced seaward 32 feet. Accumulation of sand continued from the foredune seaward to the profile limits. However, by April 2014 over half of this gain eroded primarily shed from the beachface and berm. The shoreline position retreated 28 feet with a loss of 26.64 yds<sup>3</sup>/ft. of sand eroded from the beachface. A deeper trough (-11 feet NAVD88) was scoured landward of the “Beachsaver” units while beyond the units offshore sand remained in place.

The “Beachsaver” unit crest protrudes about two feet above the beach slope offshore due to the deposition of 2 feet of sand vertically offshore. Landward of the units a deep trough was scoured that exposed 5 feet of the vertical landward face of the reef. The reef crest is 125 feet seaward of the zero elevation shoreline position (about mid-tide position) with the concrete units residing in -11 feet (landward) and -8.0 feet (seaward) of water below the NAVD 88 zero elevation. The crest protrudes up to elevation - 6 feet NAVD88. In this instance the reef units are unlikely to be encountered by swimmers this season within the middle of the groin cell. As always caution and restrictions should be in place closer to the groins.

**Figure 3. No sand was placed directly on this beach during the recent USACE project. It does appear that the rapid erosion of the updrift project beach shed some sand to this adjacent beach. The April 2013 survey conducted approximately 4 months following construction was completed showed gains on the beachface and beach. Subsequent erosion resulted in the beachface and shoreline landward retreat of nearly 30 feet with the loss of 26.64 yds<sup>3</sup>/ft. of sand removed from the beachface and offshore.**

2. The zero elevation position (NAVD 88 zero, which equals about 1.5 feet above the average low tide) in Cell 2 at Whilldin Avenues is now about 125-foot distance from the breakwater structure. A deeper trough has developed between the water's edge and the breakwater units nearly -11 feet immediately landward of the units. While about 50 feet landward of the units the depth is approximately -6 feet. The swimming area is limited, but may again be manageable this year. The CRC again recommends installing a line of floats indicating the maximum distance for swimming that should be about 30 feet from the breakwater reef. Swimming near the groins has been avoided in all cells, but here additional caution should be used as the units are slightly closer to the beach adjacent to the rocks.

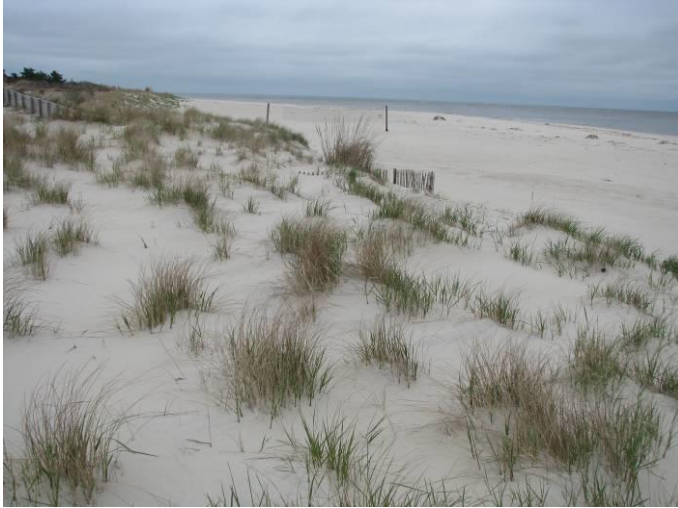
*The 2013 photo shows a well-developed dune system and wider beach. Plants have colonized the expanding foredune feature.*

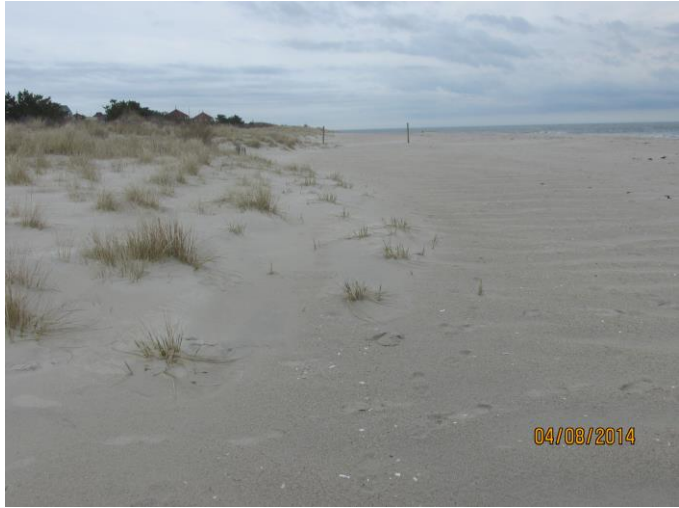
*The 2014 photo taken on April 8 shows the dune and beach have remained relatively stable. Plants continue to spread over the foredune slope and onto the upper beach.*

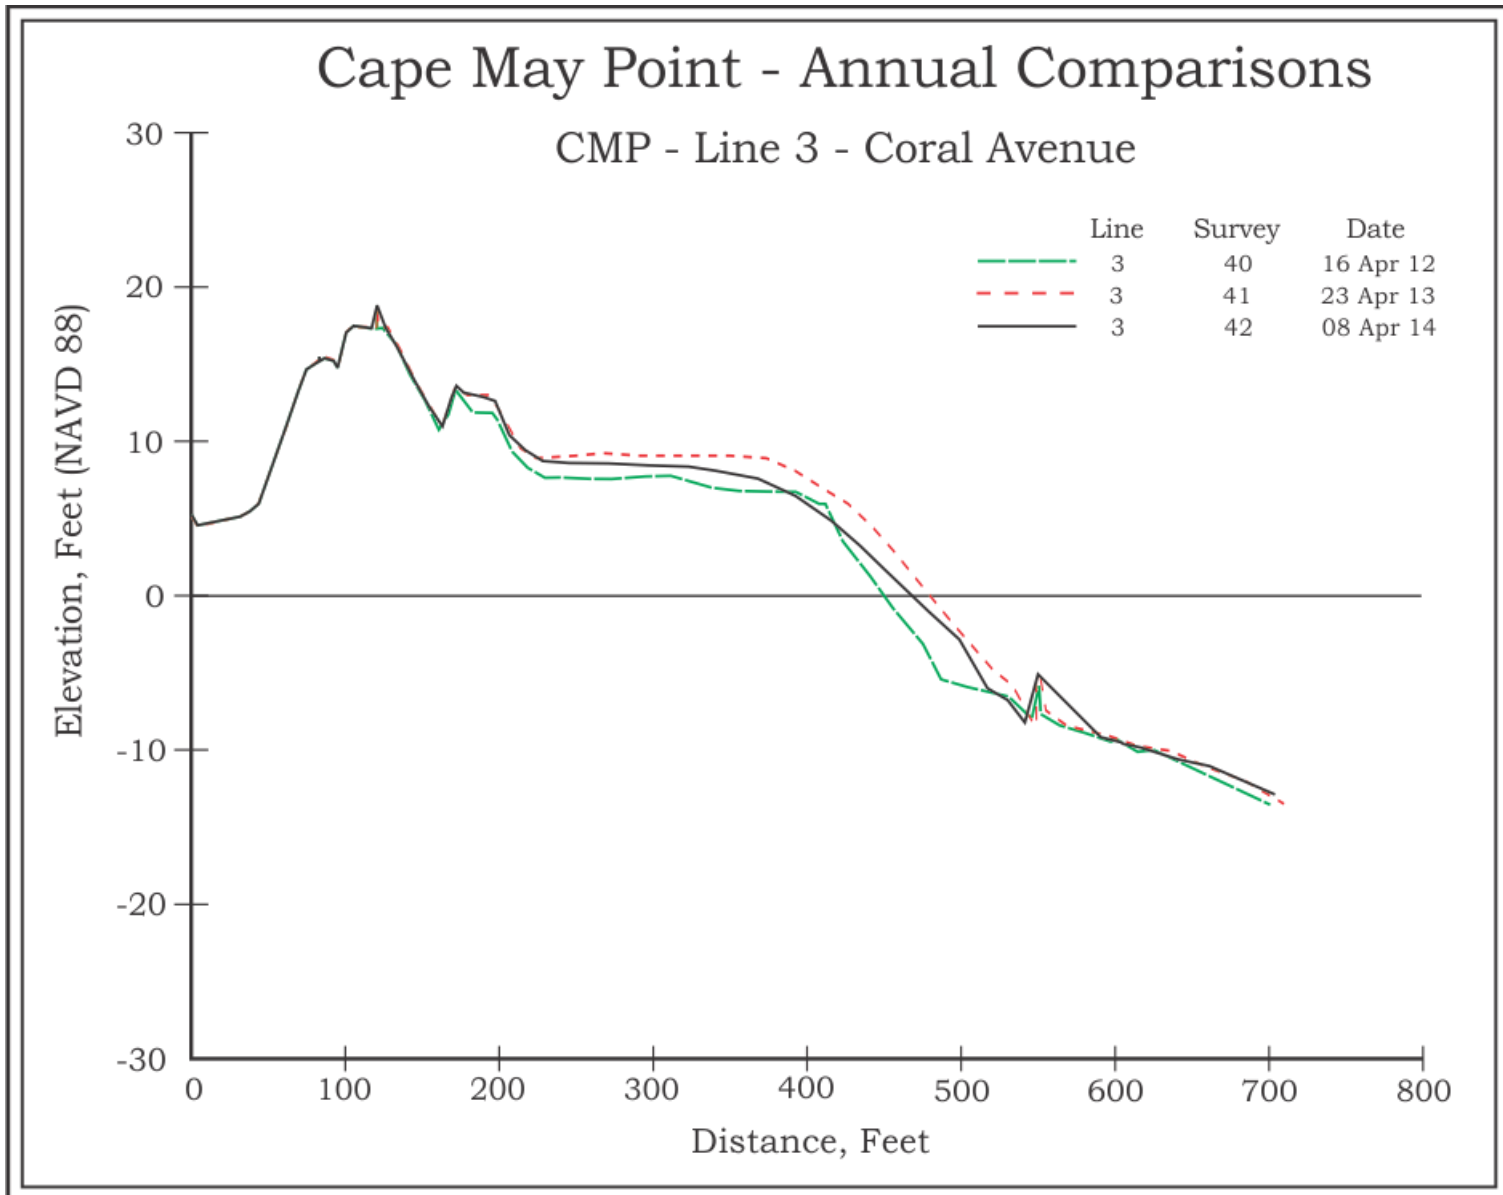
By April 2014 the beach had eroded along with the beachface slope. The shoreline position retreated landward 11 feet with a modest loss of 11.21 yds<sup>3</sup>/ft. of sand. This modest loss of beach width kept the units in relative close proximity to the shoreline approximately 80 feet. The concrete crest lies in 5.0 feet of water at mid-tide (NAVD 88 zero datum). This location remains the most problematic in terms of swimmers encountering the structure while using the beach. There is no deep trough at the landward side of the reef structure. If the guards are diligent in keeping swimmers close to shore in shallow water less than 3-4 feet deep regardless of the tide level, water access could be allowed here. Water access near the groins where the units are closer to shore should be prohibited.

**Figure 4. Again no sand was reportedly placed directly on this beach during the recent USACE project. Longshore and cross-shore transport moved sand onto this beach by April 2013 elevating the beach and pushing the beach seaward nearly 30 feet. Subsequent erosion in late 2013 through April 2014 reduced nearly half the elevation and beach width gained last year. The result was a shoreline retreat of 11 feet with 11.22 yds<sup>3</sup>/ft. of sand stripped from the site this year.**

3. Cell 3 at Coral Avenue the shoreline position has retreated slightly the breakwater units in April were approximately 75 – 80 feet from the shoreline position (zero datum). The beachface slope remains fairly steep with development of a small trough landward of the units -8 feet. In the current beach configuration this location would only allow approximately half the distance between the reef and the mid-tide beach's water edge as safe for water activity. It is the CRC recommendation that entry into the water be limited to no more than 3-foot depths.

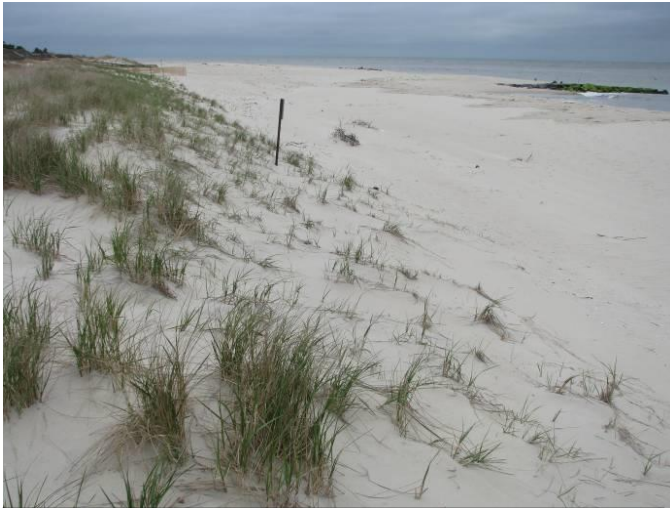
*By April 2013 the beach had returned to a width seen in 2011. Sand was blown into the foredune zone and added to the berm by the events of the past winter.*

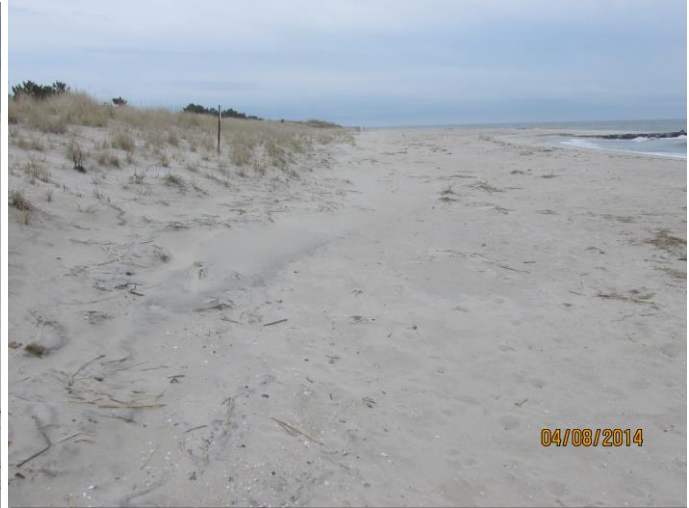
*Photo above was taken from the dune toe on April 8, 2014. The dune system remained stable but the beachface had eroded nearly 40 feet landward this year.*

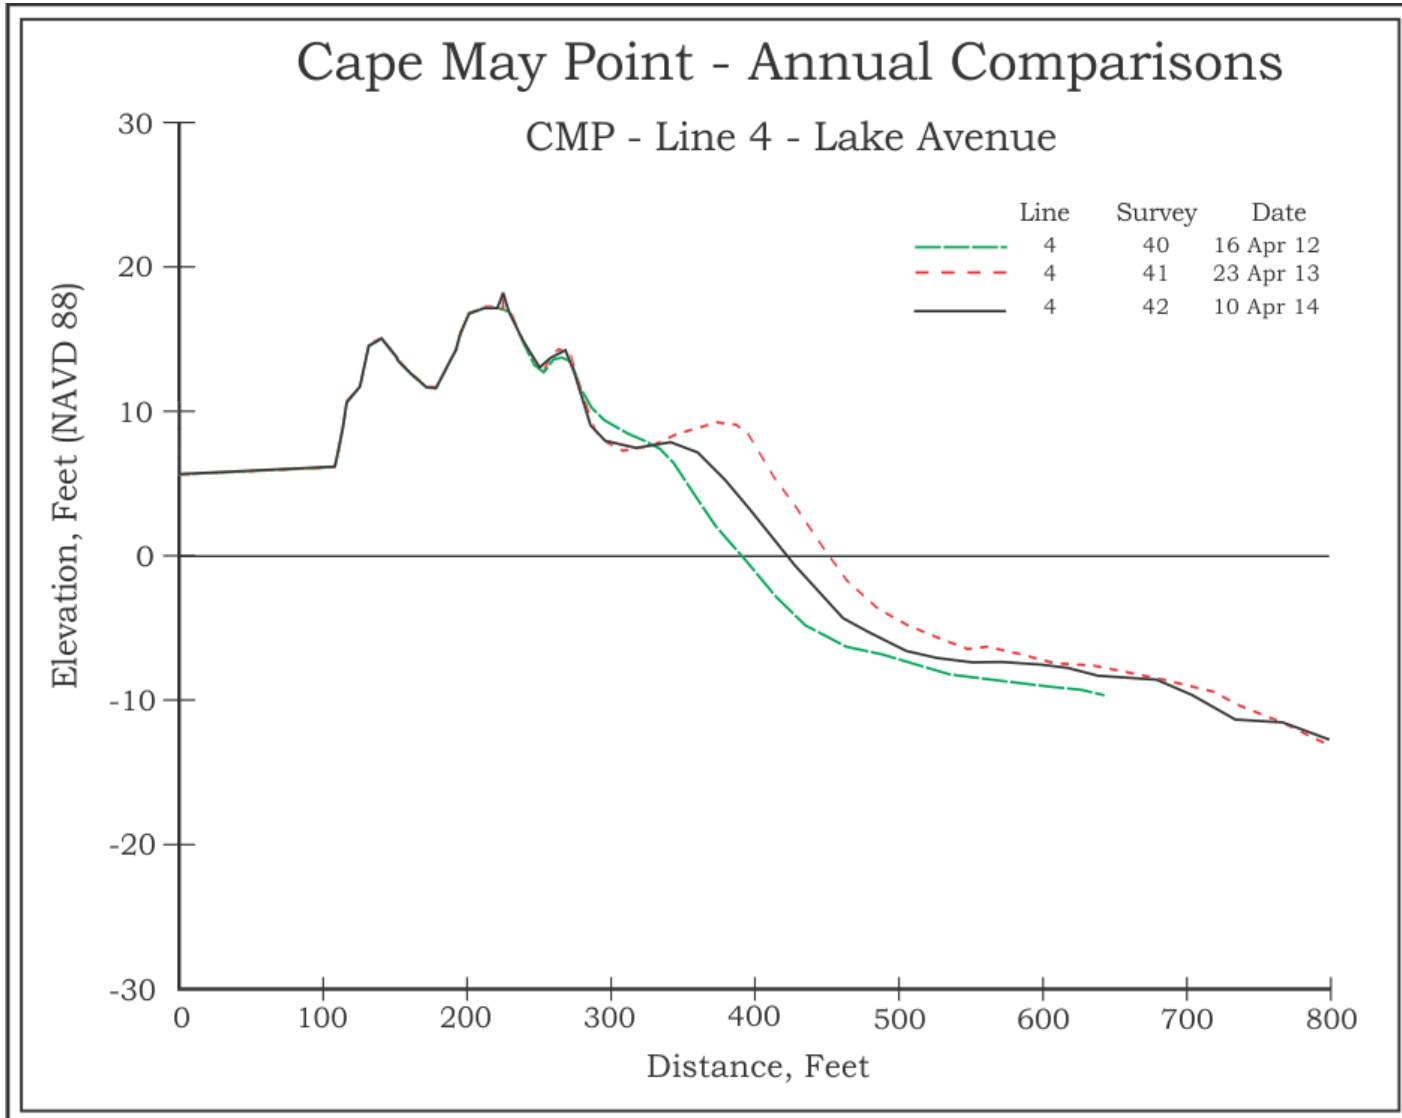
By April 2014 approximately half the beach width added during the recent project was eroded. The shoreline retreated 29 feet with a loss of 24.79 yds<sup>3</sup>/ft. of sand scoured from the beachface slope and swept by longshore currents from the beach cell. The dune and offshore seafloor were relatively stable. Despite the recent losses this beach should still support recreational activity this summer. This location remains one of the more desirable bathing beaches in the Borough with approximately 80 feet of dry recreational beach, a gradual descent into deeper water and a relatively large, shallow offshore platform area for recreational swimming.

**Figure 5. Following Hurricane Sandy the USACE 2nd maintenance nourishment project restored the beach approximately 37,000 cubic yards of sand was added to the recreational beach berm and beachface at the Lake Avenue beach cell. The project increased the beach elevation up to 2.5 feet (10-11ft. NAVD88) and pushed the beach width seaward 60-70 feet. By April 10, 2014 erosion resulted in a shoreline position retreat of 29 feet with a loss of 24.79 yds<sup>3</sup>/ft. of sand cut from the beachface slope.**

4. Cell 4 has no structures offshore and a relatively flatter nearshore slope. This site remains overall a good option for a swimming beach in Cape May Point this season. The shallow slope in the water will be very welcome at low tide for children and their parents/grandparents.

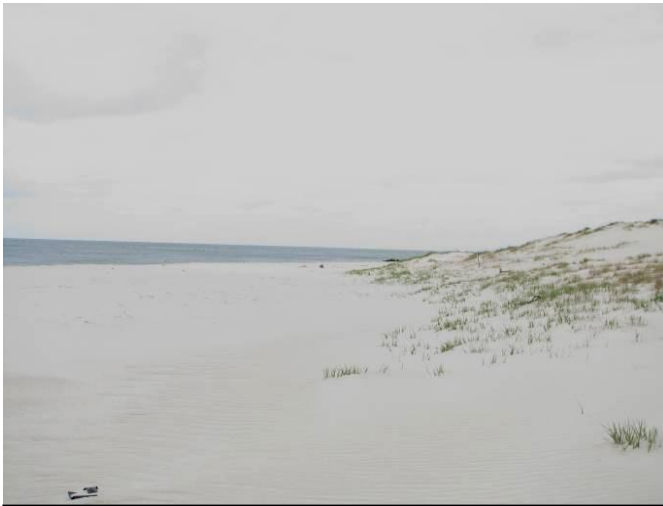
*The April 2013 photo shows a well-developed dune system and wide recreational beach berm. Dune grass had colonized the seaward slope to the dune toe.*

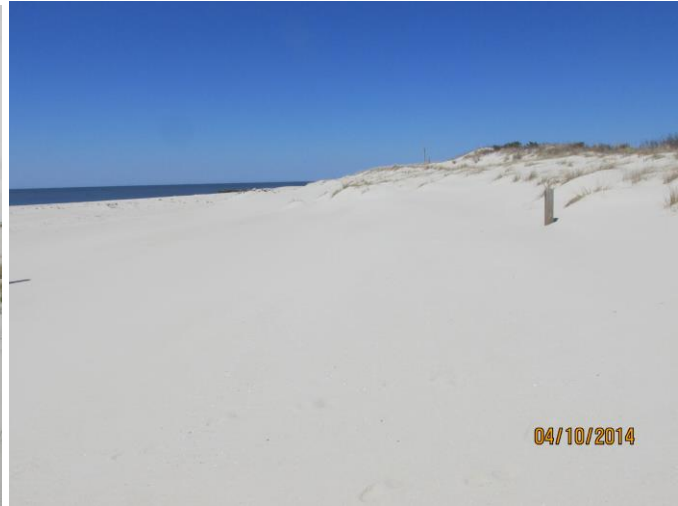
*The photo taken on April 10, 2014 shows a significant accumulation of aeolian sand on the seaward slope. Sand deposition buried the dune grass on the seaward slope. The beach berm remained stable this year.*

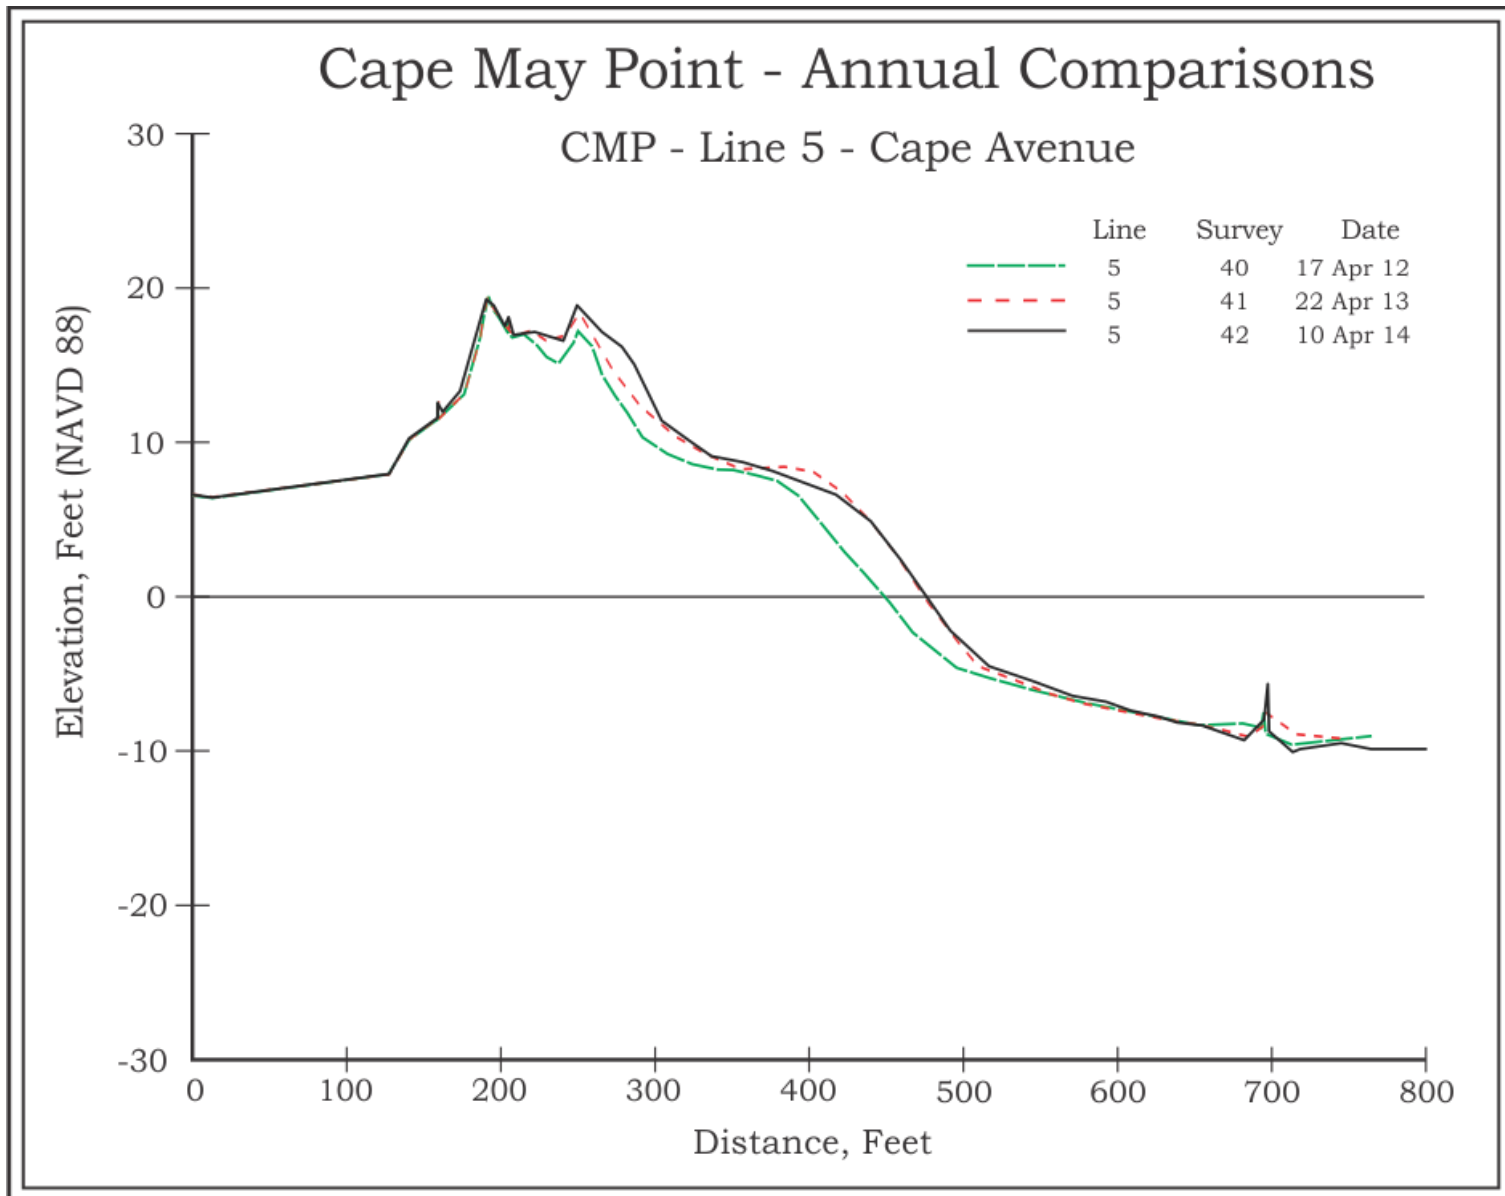
In 2012 the beach width declined in width and elevation. No sand was placed west of Lake Drive during the 2013/2013 USACE project but natural recovery added 20.63 yds<sup>3</sup>/ft. of sand to the system pushed the shoreline position seaward 25 feet and restored most of the eroded beach width and elevation. Aeolian sand accumulated on the seaward slope and crest of the dune. Through April 2014 the beach width remained relatively stable with aeolian sand added to the dune system across the seaward crest to the toe. The sand added to the dune produced a modest volume gain with 3.49 yds<sup>3</sup>/ft. of sand added. By April 10<sup>th</sup> the dune system had expanded to 200 feet in width with a landward and seaward ridge crest elevation of 19 feet NAVD 88. This additional volume, width and height added to the dune enhanced the system's storm protection for oceanfront properties and infrastructure.

**Figure 6. No sand was reportedly placed directly on this beach during the recent USACE project. Longshore and cross-shore transport moved sand onto this beach by April 2013 elevating the beach and pushing the beach seaward nearly 30 feet, aeolian sand accumulates across the seaward dune slope onto the seaward dune crest. From April 2013 to April 2014 the beach remained remarkably stable while aeolian sand that accumulated on the seaward dune slope added 3.49 yds<sup>3</sup>/ft. of sand here.**

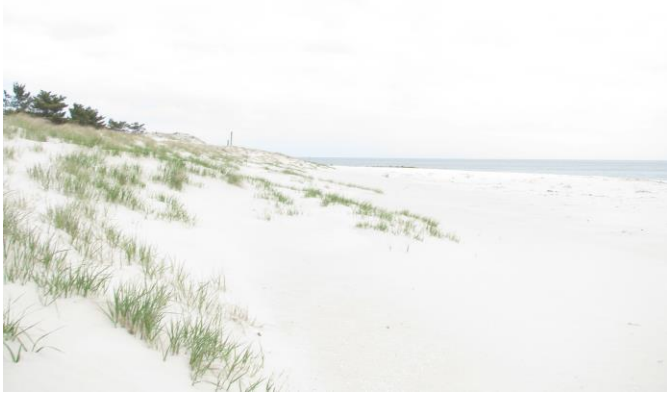
*The photo taken on April 2013 shows dune grass partially buried in recent aeolian sand deposition. The dune system and beach are well-developed and stable.*

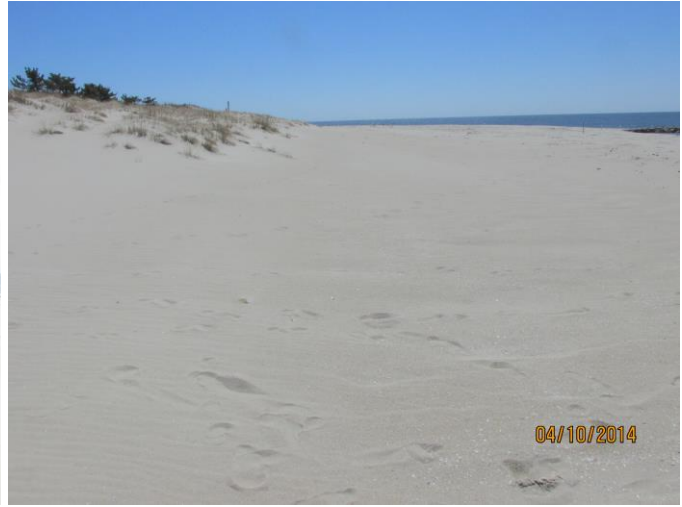
*Aeolian sand continued to accumulate and has buried the dune grass on the seaward slope by April 10, 2014. The recreational beach berm remained stable and provides ample recreational space for beach patrons.*

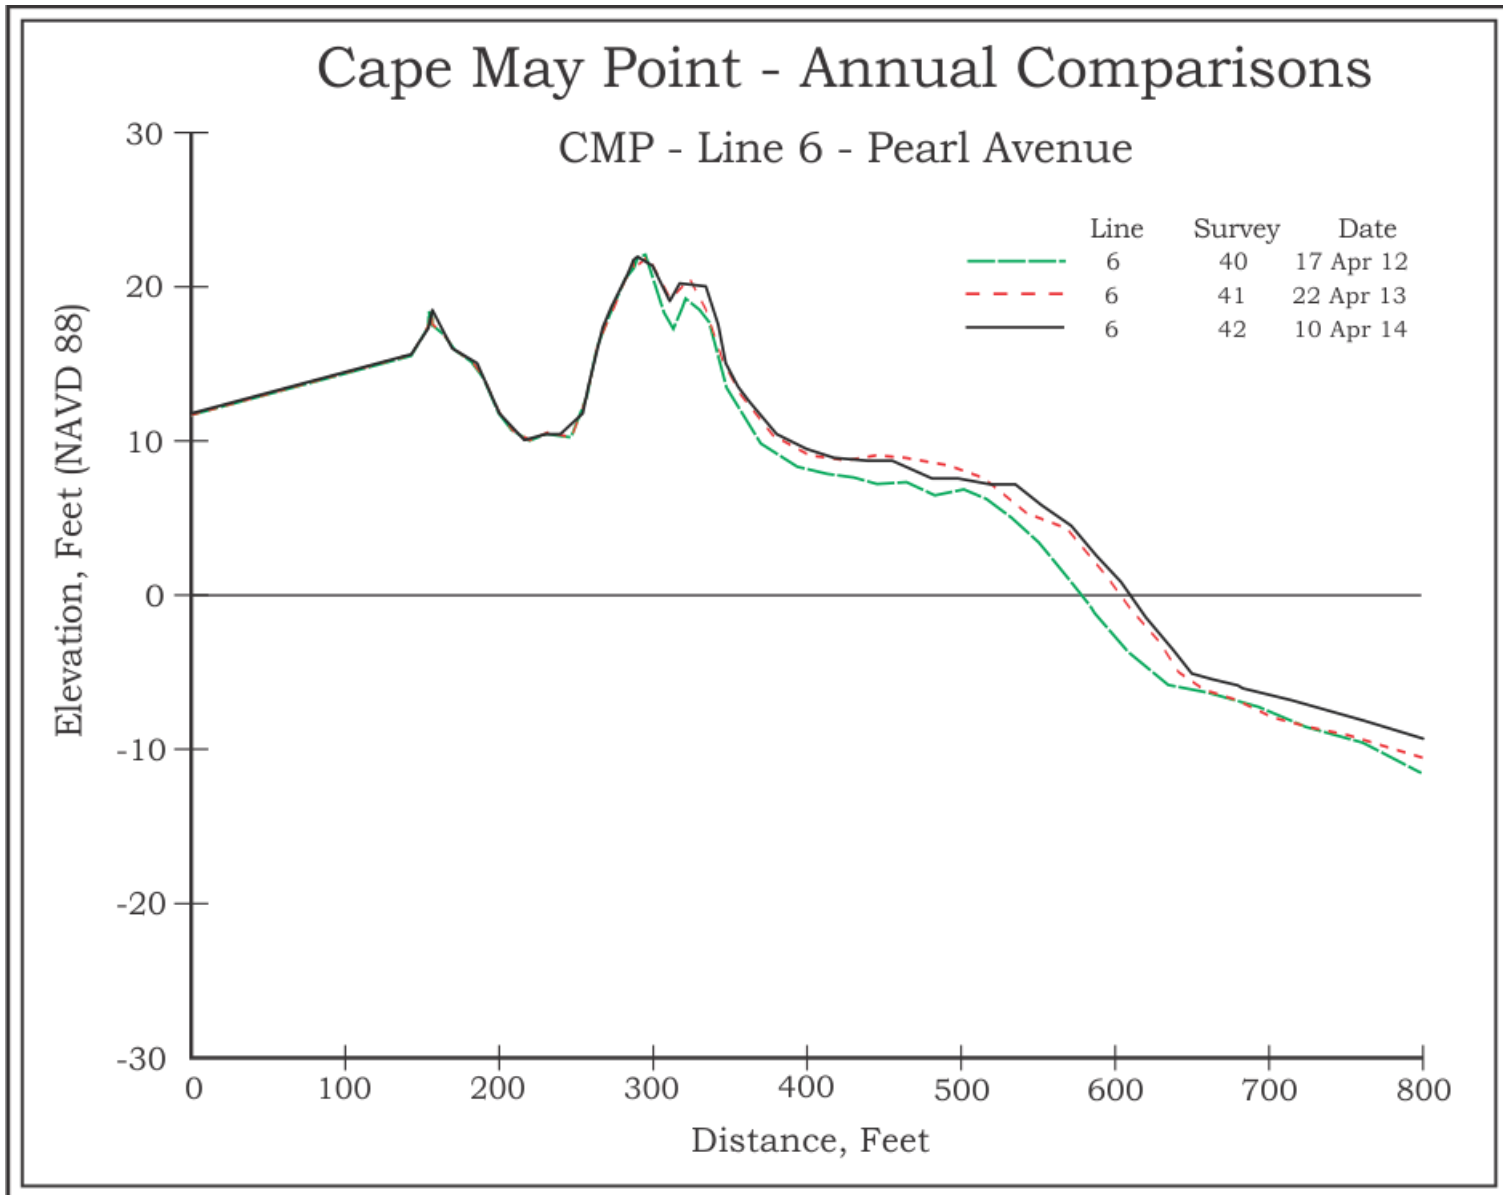
By April 2014 more sand had entered the system. Sand accumulated offshore and on the beachface slope, aeolian sand was deposited on the foredune slope and crest. The site gained an additional 11.61 yds<sup>3</sup>/ft. of sand by April 10 again likely derived from sand shed off the project beaches and carried west by longshore currents. By the April 2014 survey the dry recreational beach berm extended nearly 200 feet seaward of the dune toe at elevation 8.5 feet NAVD88 with a relatively gentle slope onto a shallow platform that continued offshore nearly 200 feet from the current shoreline position. These beach and nearshore changes make this beach an excellent option for most recreational activities.

**Figure 7. No sand was reportedly placed directly on this beach during the most recent USACE project. Natural processes moved 23.38 yds<sup>3</sup>/ft. of sand onto this beach by April 2013 elevated the beach up to 2 feet and pushed the beach seaward nearly 30 feet, aeolian sand accumulated across the seaward dune slope onto the seaward dune crest. From April 2013 to April 2014 the beach remained remarkably stable to accretive on the offshore slope with 11.61 yds<sup>3</sup>/ft. of sand added here.**

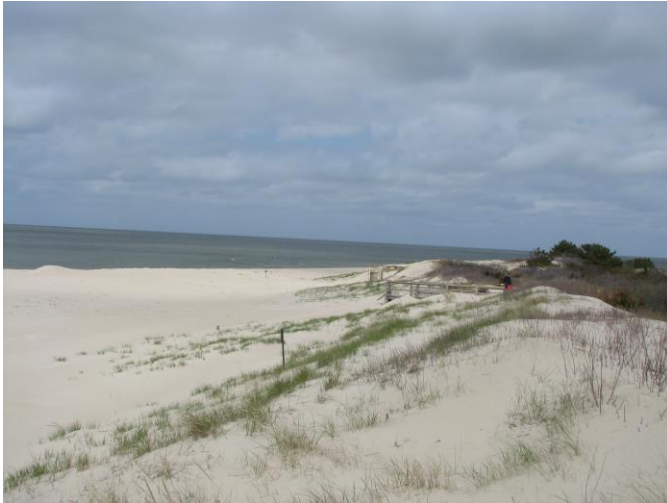
*The April 2013 photo shows sand was added everywhere between the crest of the dune to the berm ridge. Dune grass plants are partially buried by the new aeolian deposition.*

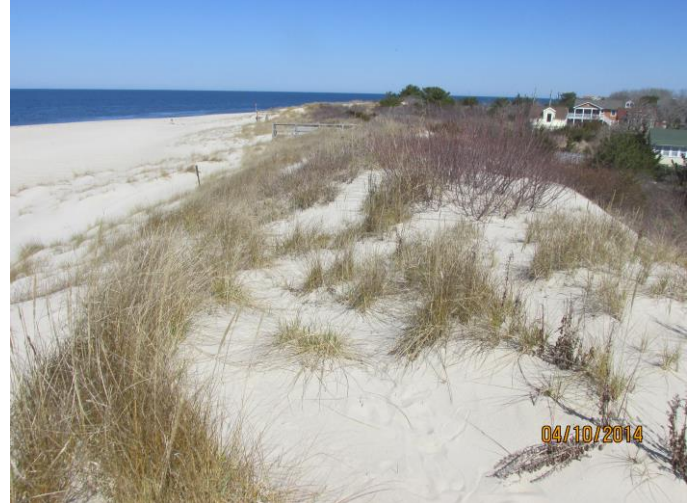
*The April 10, 2014 photo shows continued sand accumulation on the seaward dune slope. The recreational beach berm width has expanded seaward approximately 20 feet during the year.*
