THE RICHARD STOCKTON COLLEGE OF NEW JERSEY

**Introduction:**

The annual survey of the nine cross section stations on the municipal beach was completed by the Richard Stockton College of New Jersey Coastal Research Center on April 8 and 10, 2014. These were compared to previous studies that were completed in April 2012 and April 2013. This work completes the annual review of the municipal beaches prior to the 2014 tourist season.

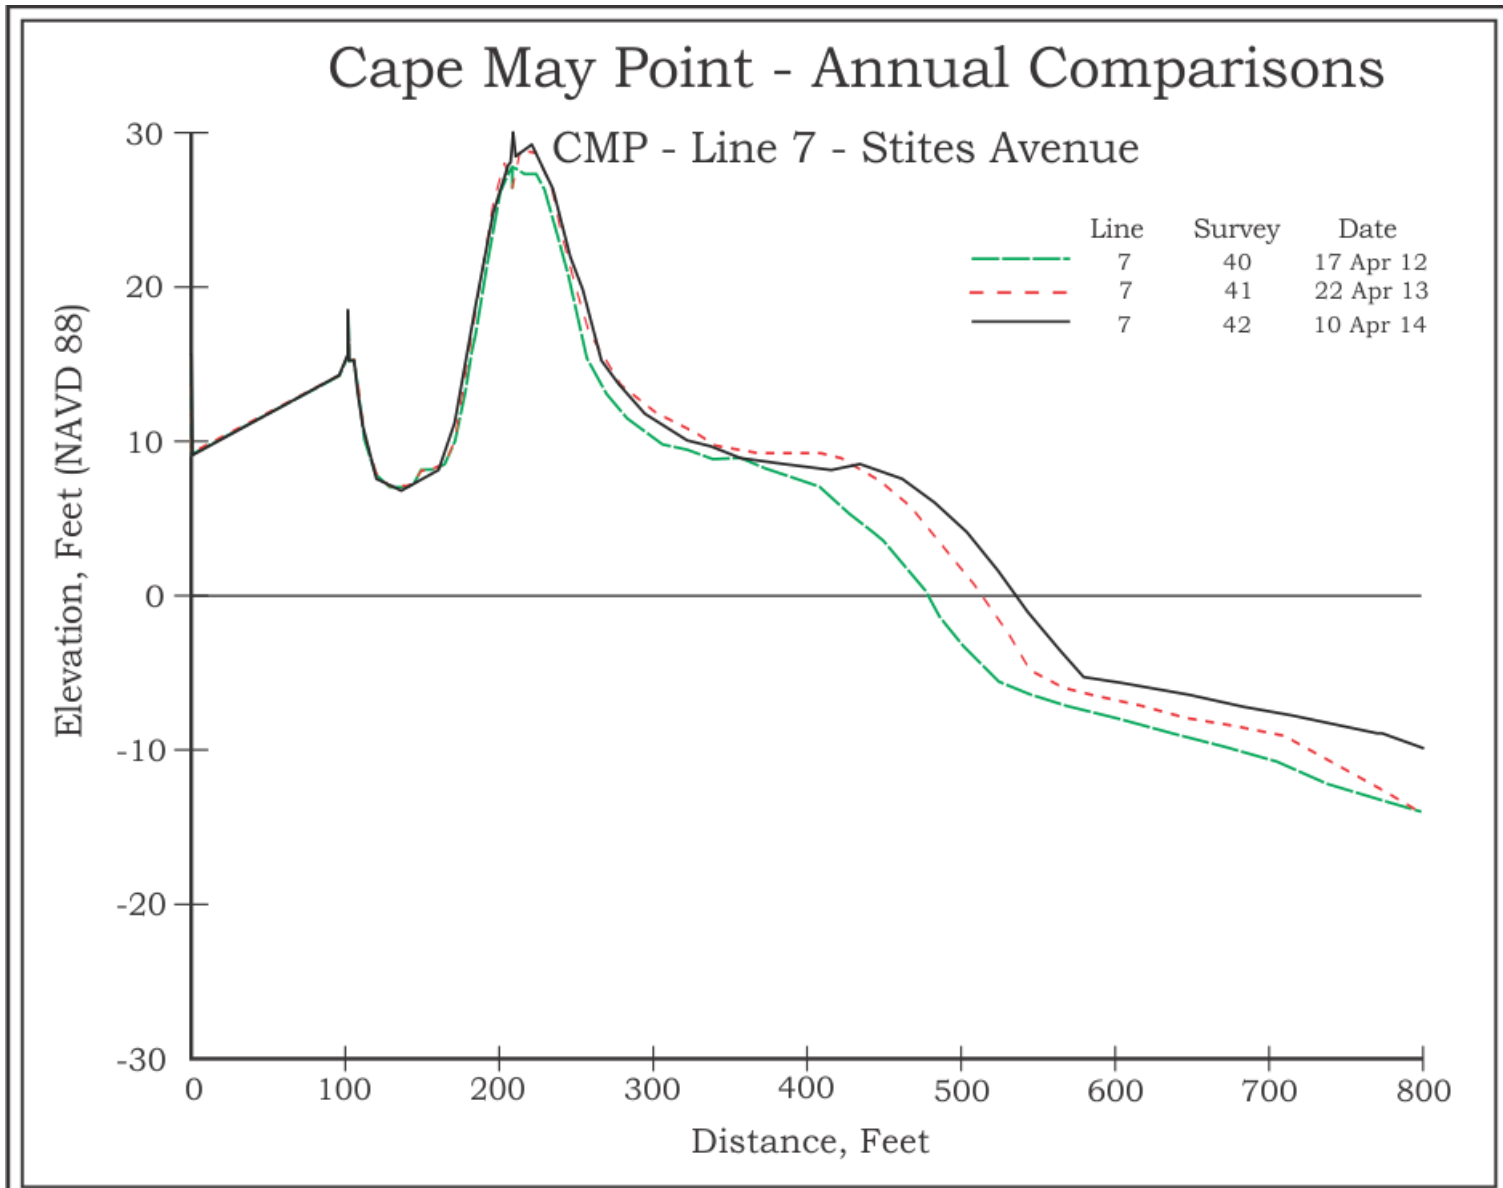
By April 2014 another lobe of sand had moved landward from offshore onto the nearshore and beachface slope up to the berm crest. Modest aeolian transport deposited a thin veneer of sand across the primary dune feature. The net annual gain was 33.51 yds<sup>3</sup>/ft. of sand with a 22-foot advance in the shoreline position. Sand added to the offshore slope raised the seafloor elevation that created a shallow platform that extended approximately 250 feet seaward of the shoreline position (zero datum). From 2012 to 2014 sand added to the nearshore and offshore seafloor has raised the elevation between 2-4 feet. With no structures present at this location the wide dry beach should provide beach patrons with abundant recreational area and good nearshore swimming conditions for the summer season. As always caution should be used when determining if swimming should be allowed in deeper water near the end of the groins or along the rocks.

**Figure 8. No sand was reportedly placed directly on this beach during the most recent USACE project. Natural processes moved 44.21 yds<sup>3</sup>/ft. of sand onto this beach by April 2013 elevated the beach several feet and pushed the beach seaward approximately 30 feet, aeolian sand accumulated across the seaward dune slope onto the seaward dune crest. From April 2013 to April 2014 the beach gained sand from the beachface seaward to the offshore limits with 33.51 yds<sup>3</sup>/ft. of sand added here as the shoreline advanced seaward 22 feet.**

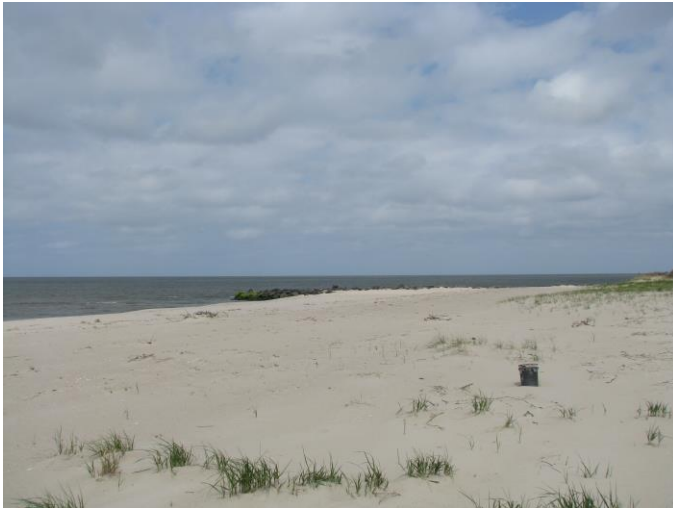
*In spite of being two cells removed from direct sand placement in 2011, this cell has gained sand on the dune and beach with little change offshore as longshore drift moved sand west filling behind the terminal groin.*

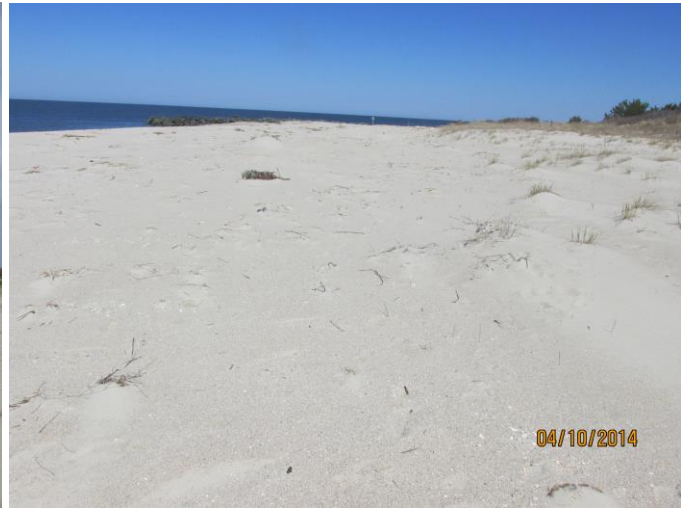
*Sand continued to accumulate both on the beachface and across the recreational beach berm. By April 10, 2014 aeolian sand had buried much of the dune grass that had colonized the lower slope and dune toe in 2013.*

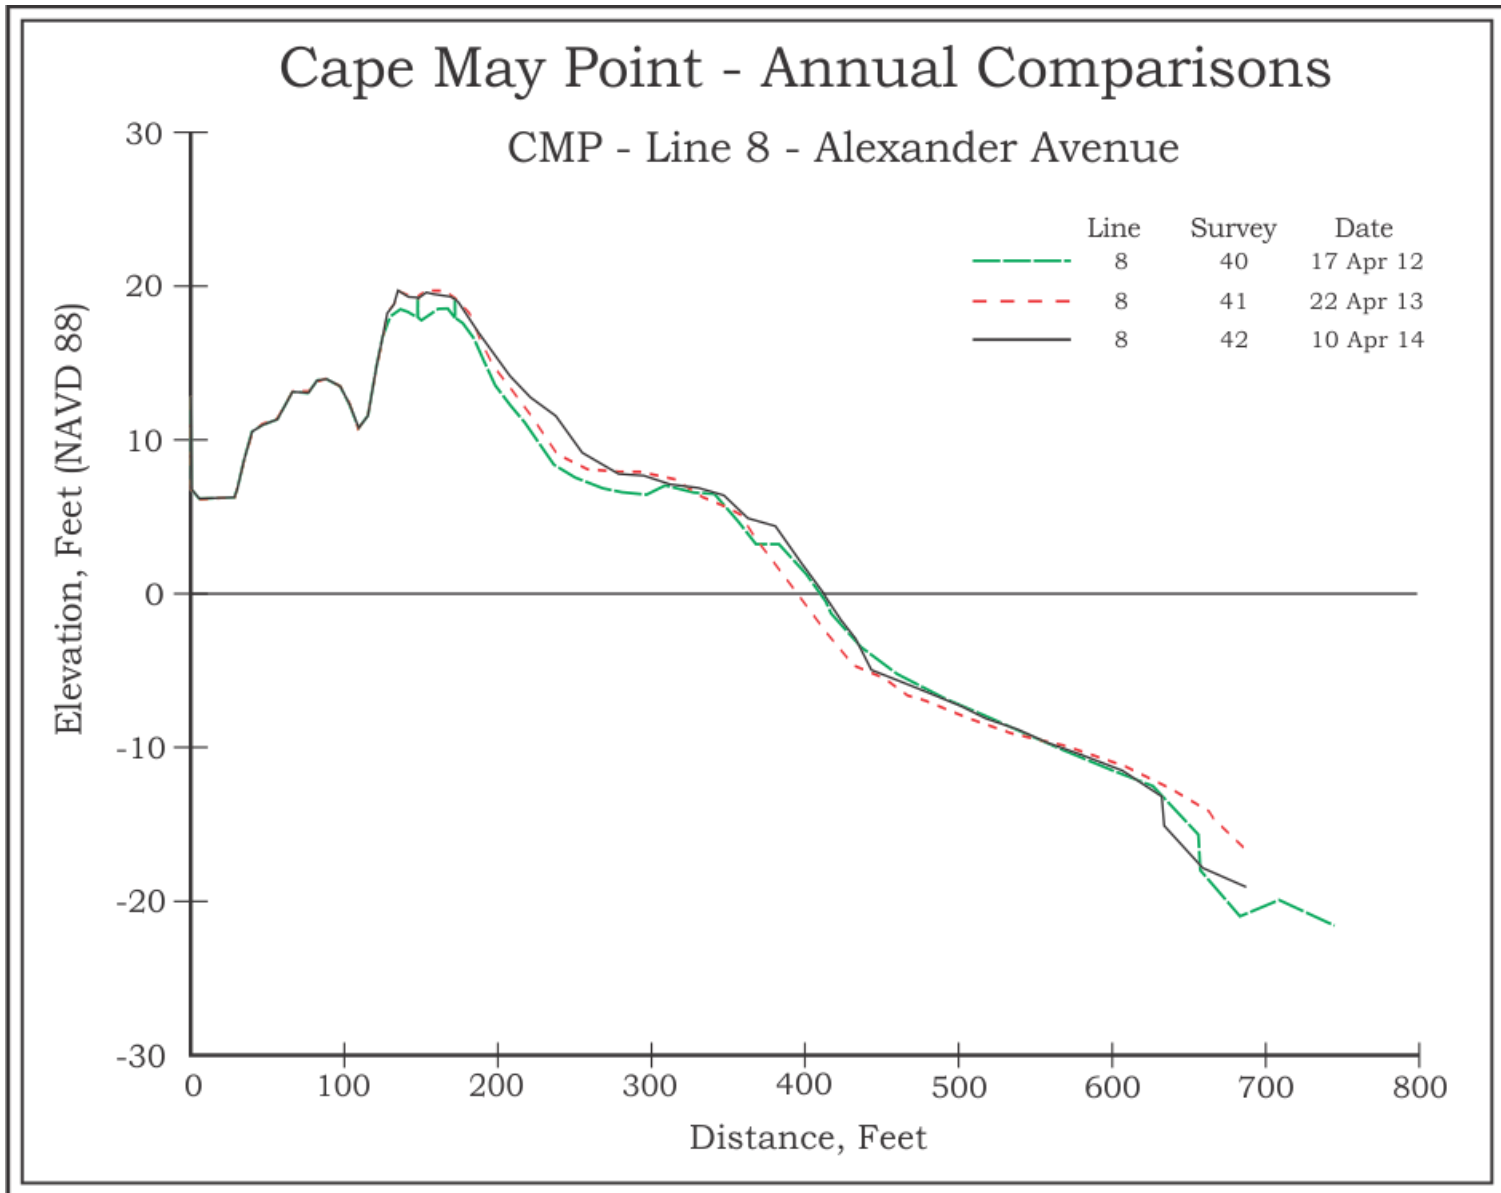
After several years of accumulation the beach continued the trend in 2013 and accumulated sand primarily on the dune and upper beach. A gain offshore offset modest erosion of the beachface slope for a net annual gain of 7.24 yds<sup>3</sup>/ft. of sand by April 2013. Through the rest of 2013 to April 2014 the dune continued to accumulate sand from the seaward crest to the seaward toe. Sand moved onshore added to the beachface slope that advanced the shoreline position seaward 17 feet. The net annual volume change was a modest gain of 4.45 yds<sup>3</sup>/ft. of sand with onshore gains partially offset by a loss in the seafloor elevation near the profile limits. The dry beach remains wide enough to support summer recreational activity onshore while the nearshore slope is steeper in this cell with water depths of -10 feet NAVD88 within 100 feet of the shoreline. The steeper slope and drop off near the end of the groins along with strong tidal currents in this region should probably limit swimming activity by most to the shallow nearshore region.

**Figure 9.** Again no sand was placed directly on this beach during the most recent USACE project. Natural processes moved 7.23 yds<sup>3</sup>/ft. of sand onto this beach by April 2013 sand accumulated across the upper beach and seaward dune slope onto the seaward dune crest. From April 2013 to April 2014 the dune, beach and beachface slope continued to gain sand the shoreline advanced seaward 17 feet with a modest net volume gain of 4.45 yds<sup>3</sup>/ft of sand.
